API Ballot 6582

Work Item Number	2413
Title of Work Item	Effect of Side Groove on the Edge Cracks for Reducing Invalid Double Cantilever Beam tests
Ballot Revision Level	1
Type of Ballot (Initial, Comment, Comment resolution (reference API ballot#), 1 st Re-ballot, 2 nd Re-ballot, etc.)	Comment
Submitter Name(s)	David Sponseller, Xin Long, Keiichi Kondo
API Document Modified	TR not published yet
Impacted Documents	None (standalone TR not referenced by another API document)
Revision Key	All black text due to initial ballot for first edition TR

Effect of Side Groove on the Edge Cracks for Reducing Invalid Double Cantilever Beam tests

API TECHNICAL REPORT 5DCB
FIRST EDITION, [MONTH] [YEAR]

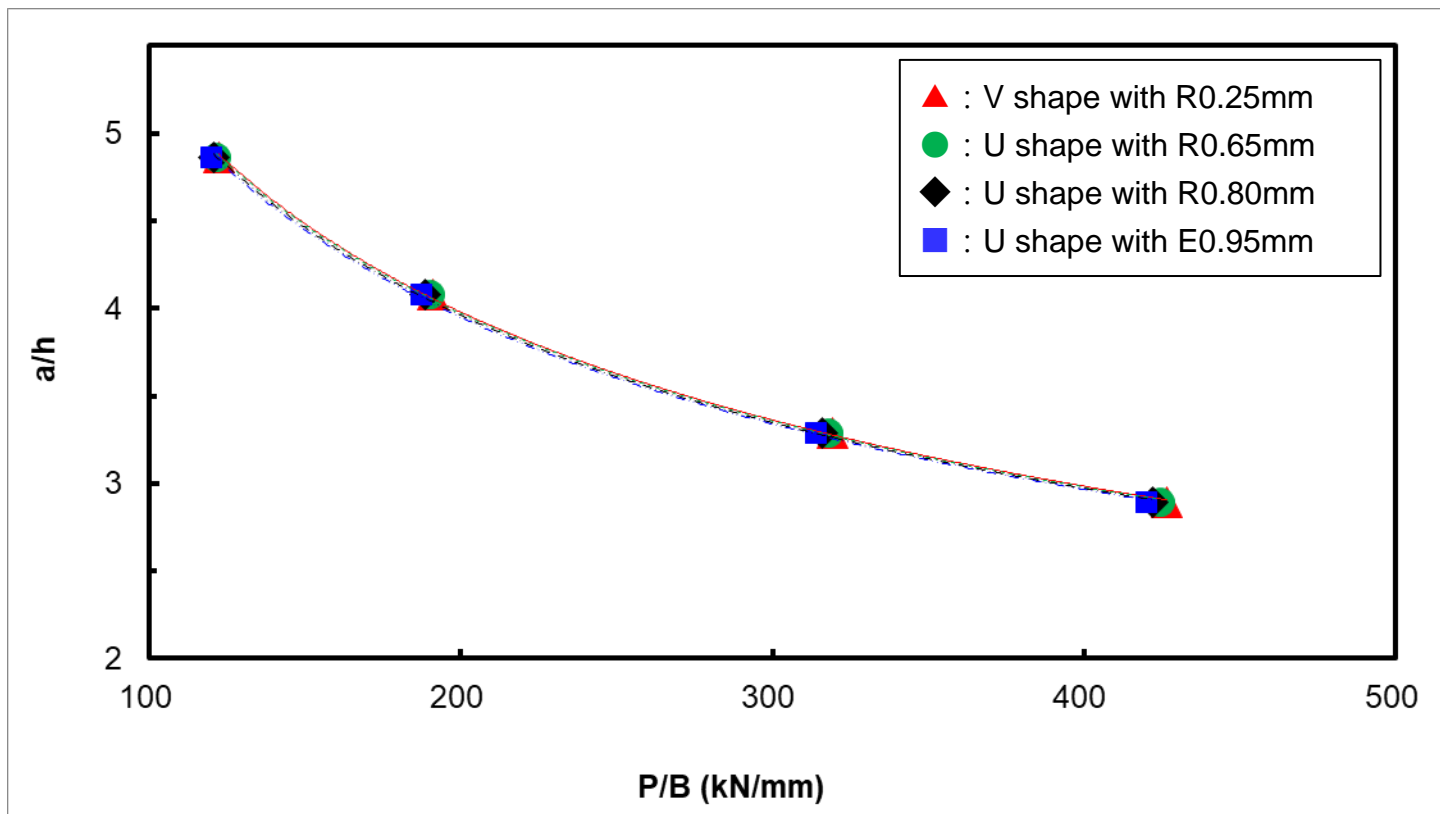
Figure A—Compliance curve evaluation by FEA

Figures 5 to 8 shows the quality assurance plot calculated by FEA for the standard V shape and the U shaped grooves for which arm displacement (δ) is 0.89mm at the chevron notch, the chevron notch with fatigue pre-crack and the EDM notch types. The loads at the upper hole at the various crack tips are obtained by FEA and plotted on the quality assurance curve applied by Equation (2) specified in NACE TM0177-2016 appendix D. Each notch configuration with V shaped

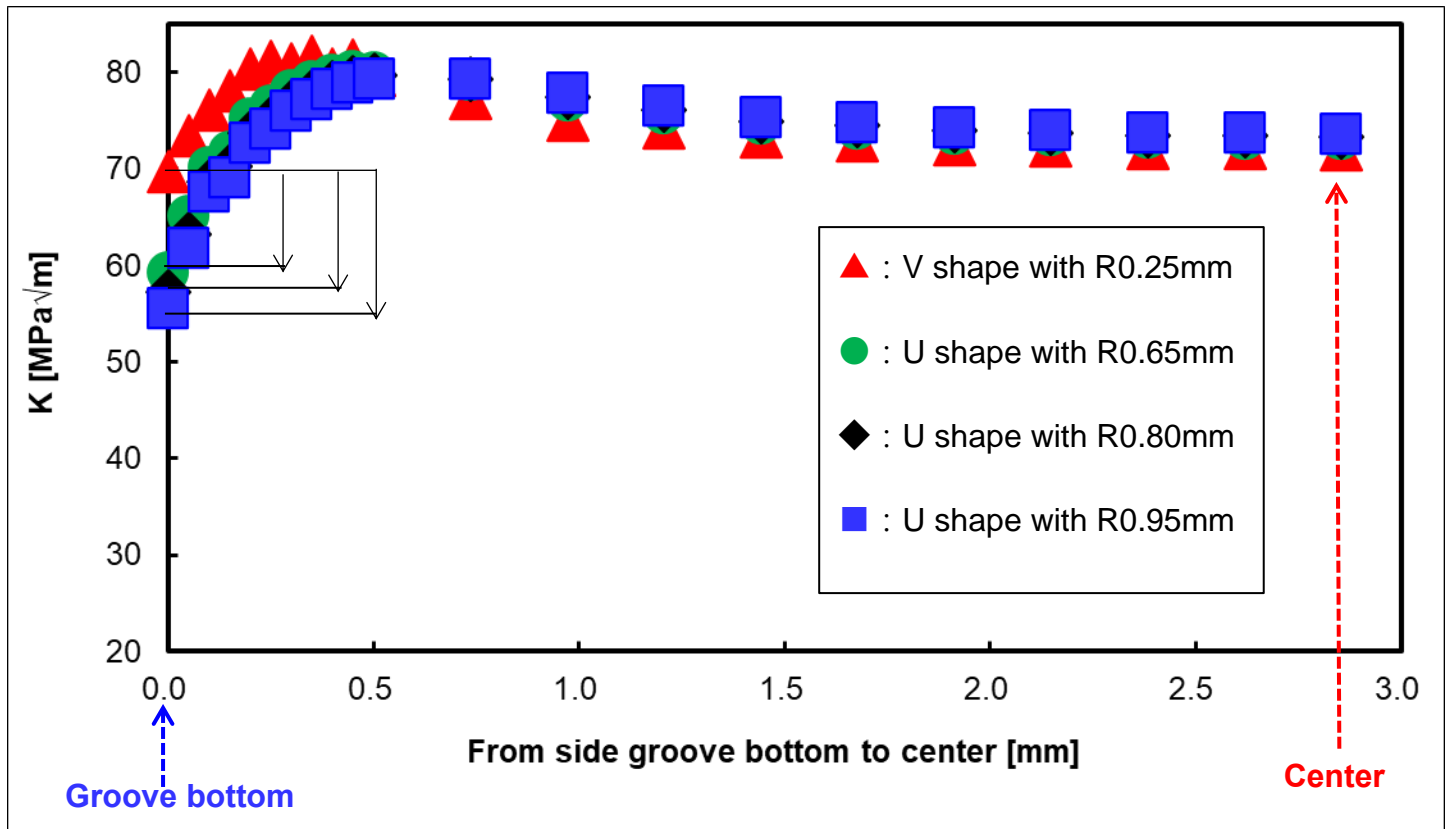
Figure 9—Through-wall K distribution

Figure 9 shows the through-wall K value distribution, for which the arm displacement (δ) is 0.89 mm at the initial crack length (a_i) of 33.75 mm from the hole, as calculated by FEA. The stress intensity factor K value at bottom of the side-groove decreased with an increase in the side-groove root (R). The K value at bottom of the side-groove was higher than that at center of thickness. Cracks can propagate at bottom of the side-groove more easily than at center of the width.

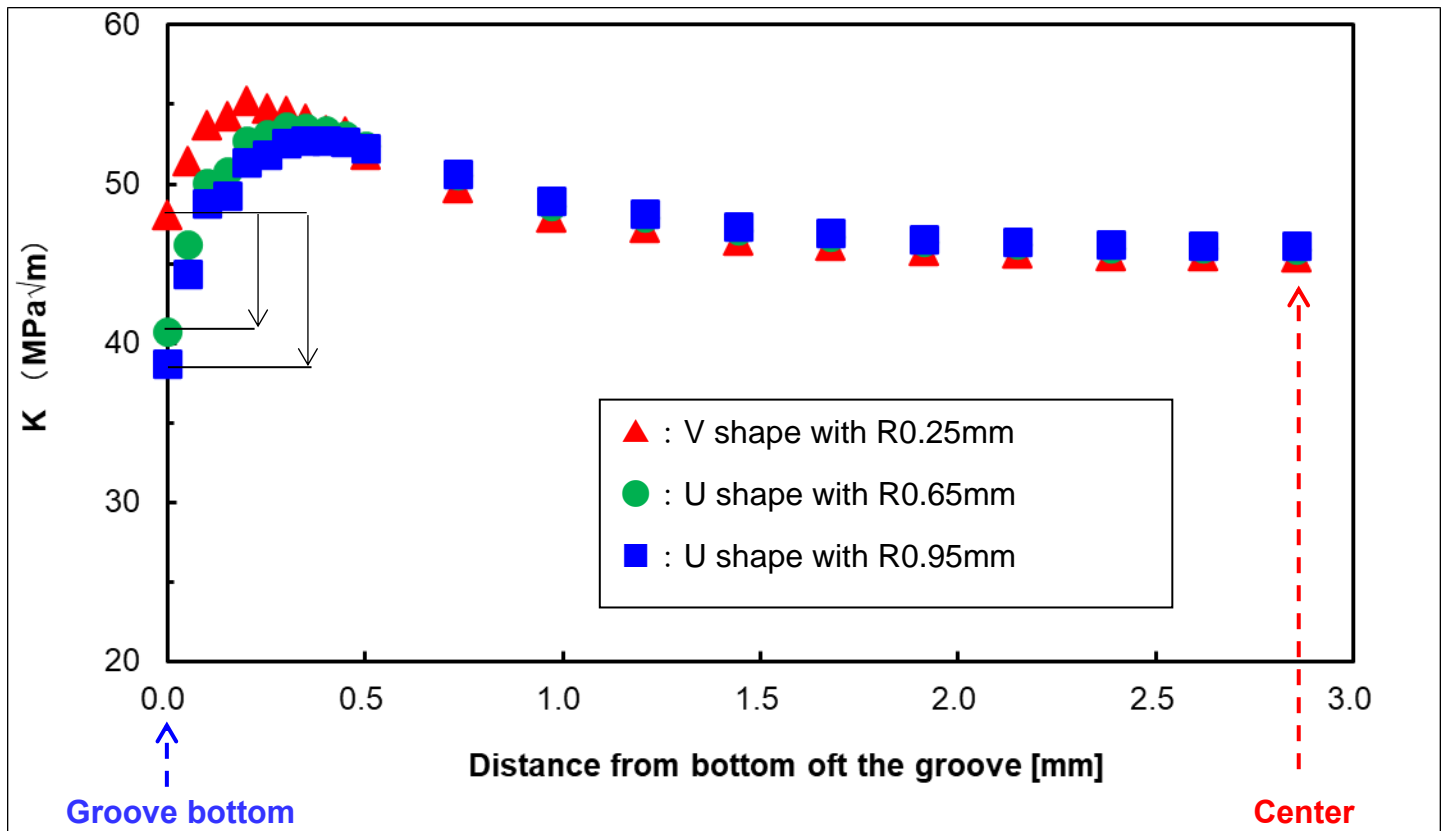
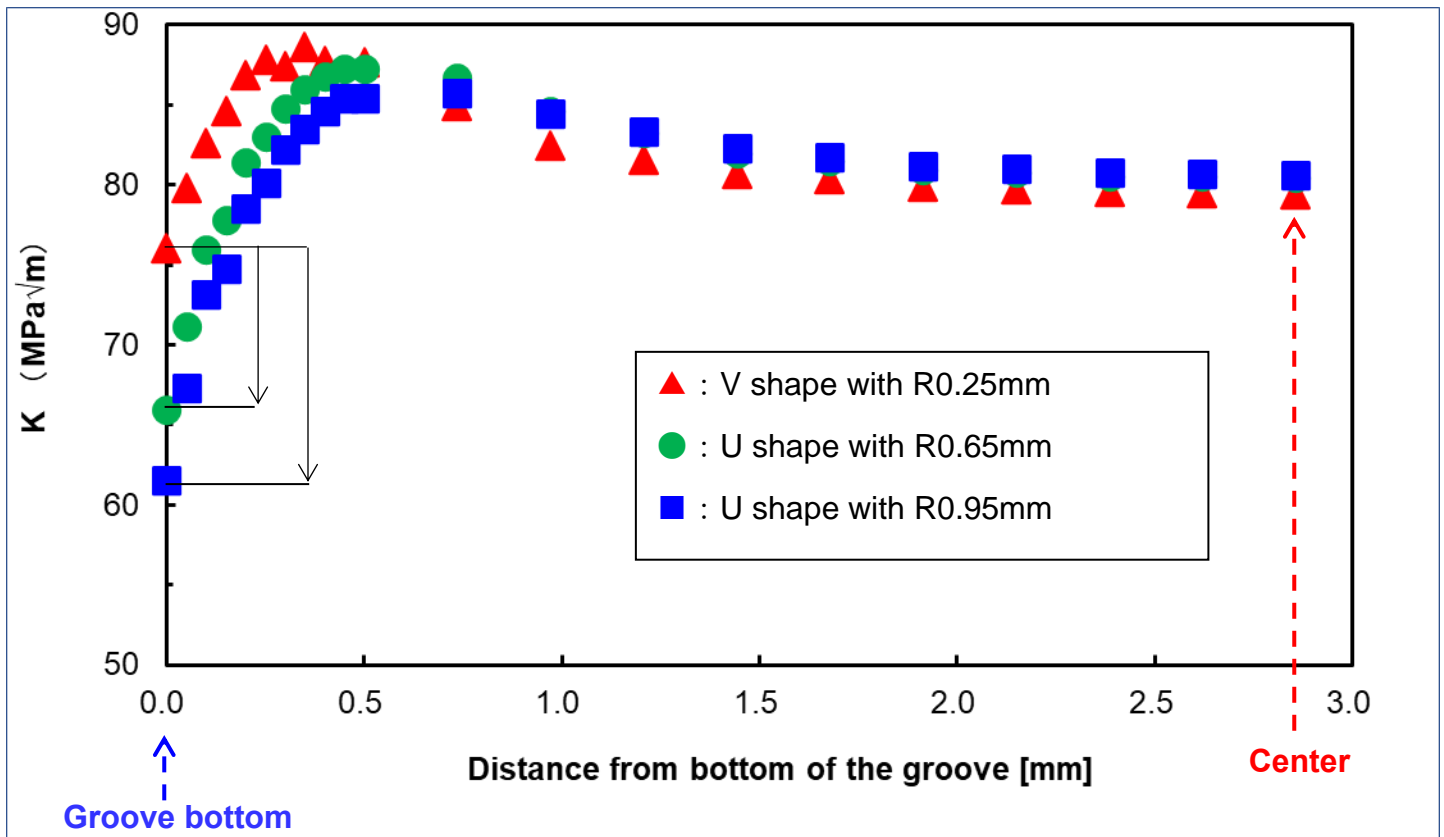
Figure 11—Comparison of K distribution at crack length “a”= 31.75mm

For DCB specimens with each shaped groove, FEA was performed to evaluate the distribution of K from bottom of the groove to center of the width when the initial crack length (a_i) is 31.75mm. The results are shown in Figure 11. Figure 11 (a) shows definition of the X-axis. Figure 11 (b) shows the results for $\delta=0.51\text{mm}$. Figure 11 (c) is for $\delta=0.89\text{mm}$. As a common feature, after reached to maximum K towards from bottom of the side groove to the inside, it decreases toward center of the width. The major difference among each specimen was found in the K distribution within the range of the maximum K from bottom of the side groove. The larger root of the bottom, the smaller K near the bottom.

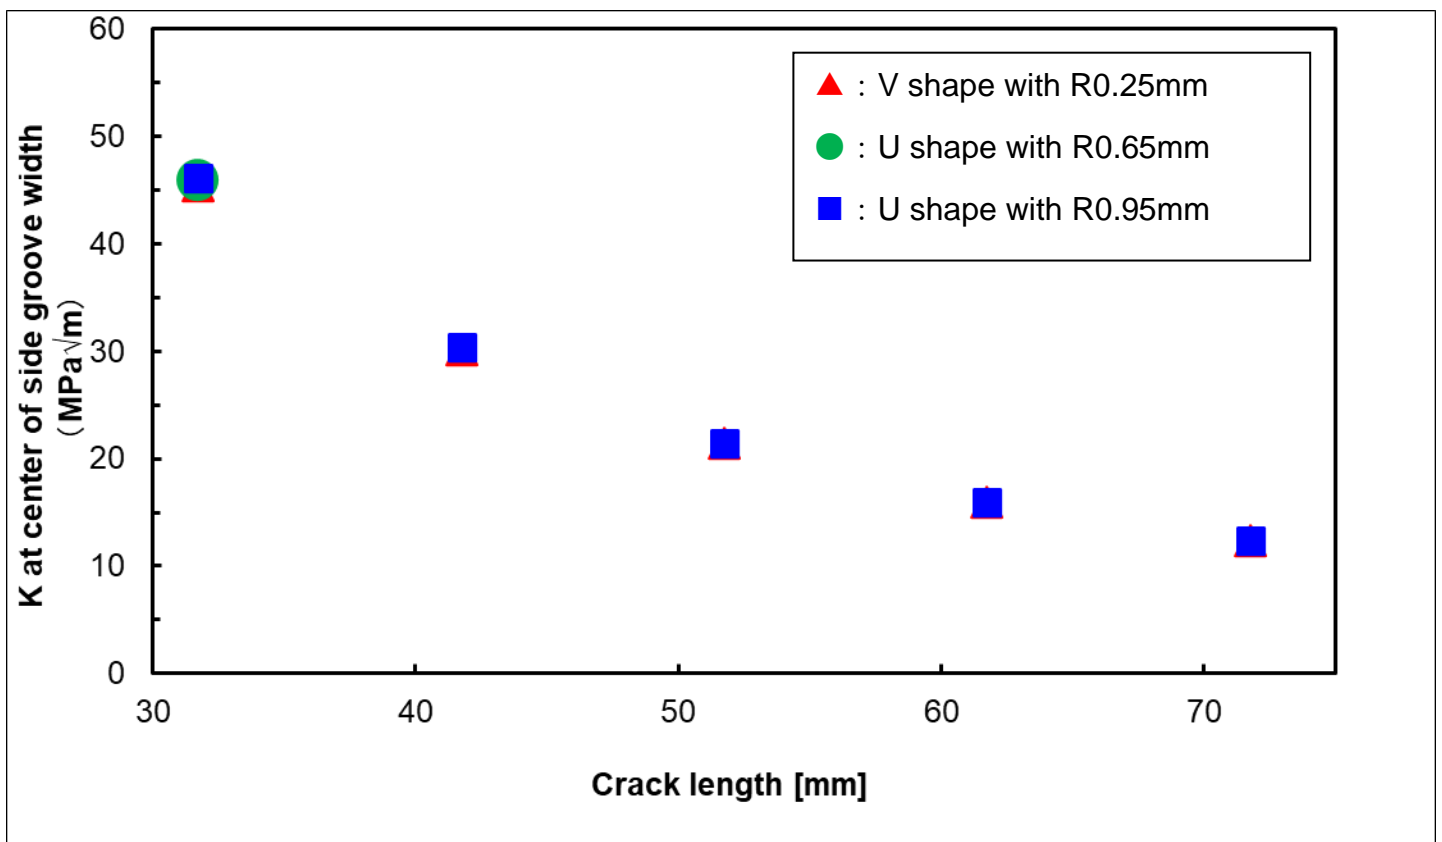
Figure 12—Variation of K distribution at center of the groove width for direction of crack propagation

Figure 12 shows distribution of K at center of the groove width when varying distance from center of the hole to crack tip. Figure 12 (a) shows the definition of the X-axis. Figure 12 (b) is for $\delta=0.51$ mm and Figure 12 (c) is for $\delta=0.89$ mm. There is no significant difference in the variation of K at center of the side groove width among the standard V shaped groove with R 0.25mm and the U shaped grooves with R0.65mm and with 0.95mm.

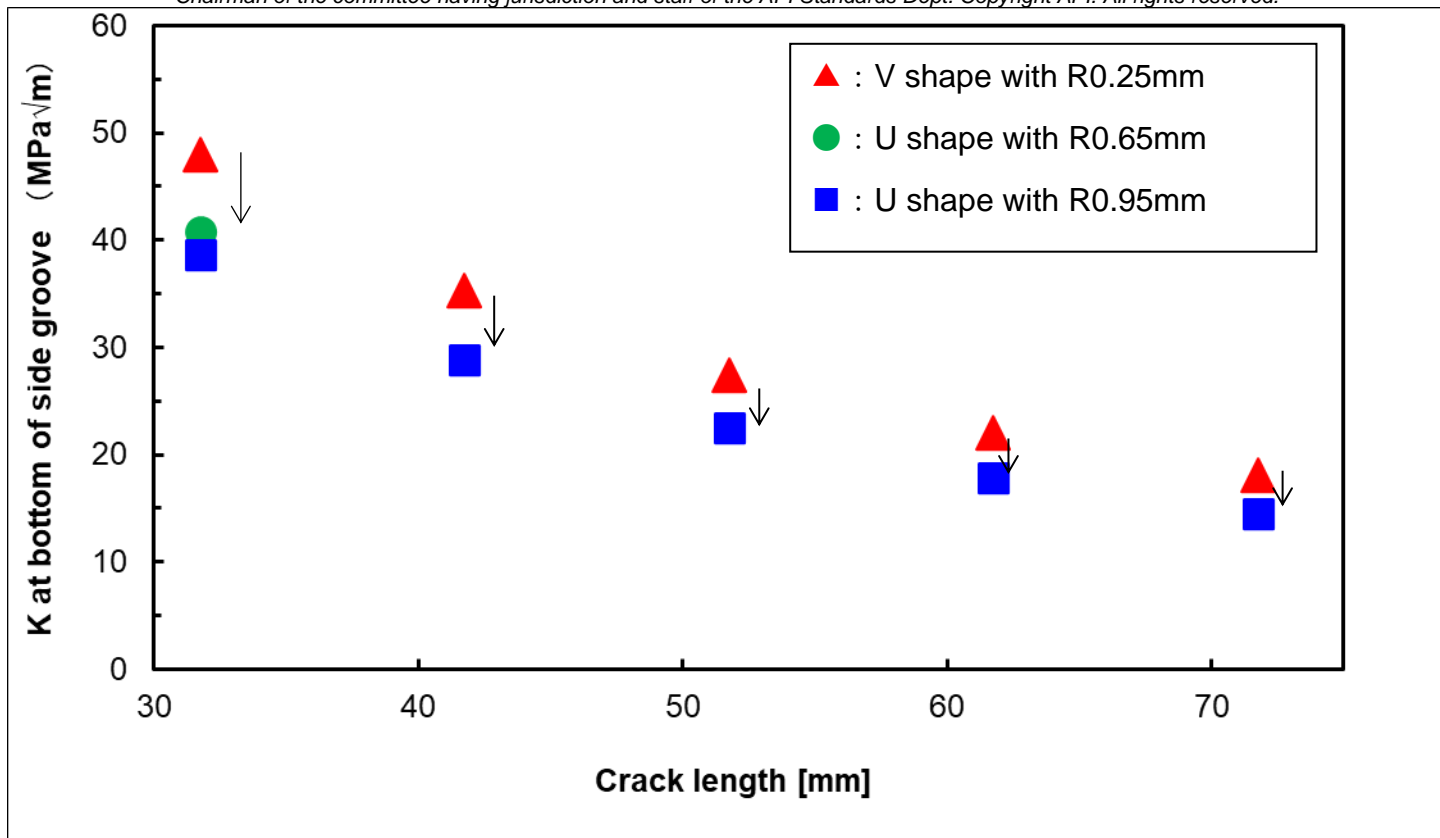
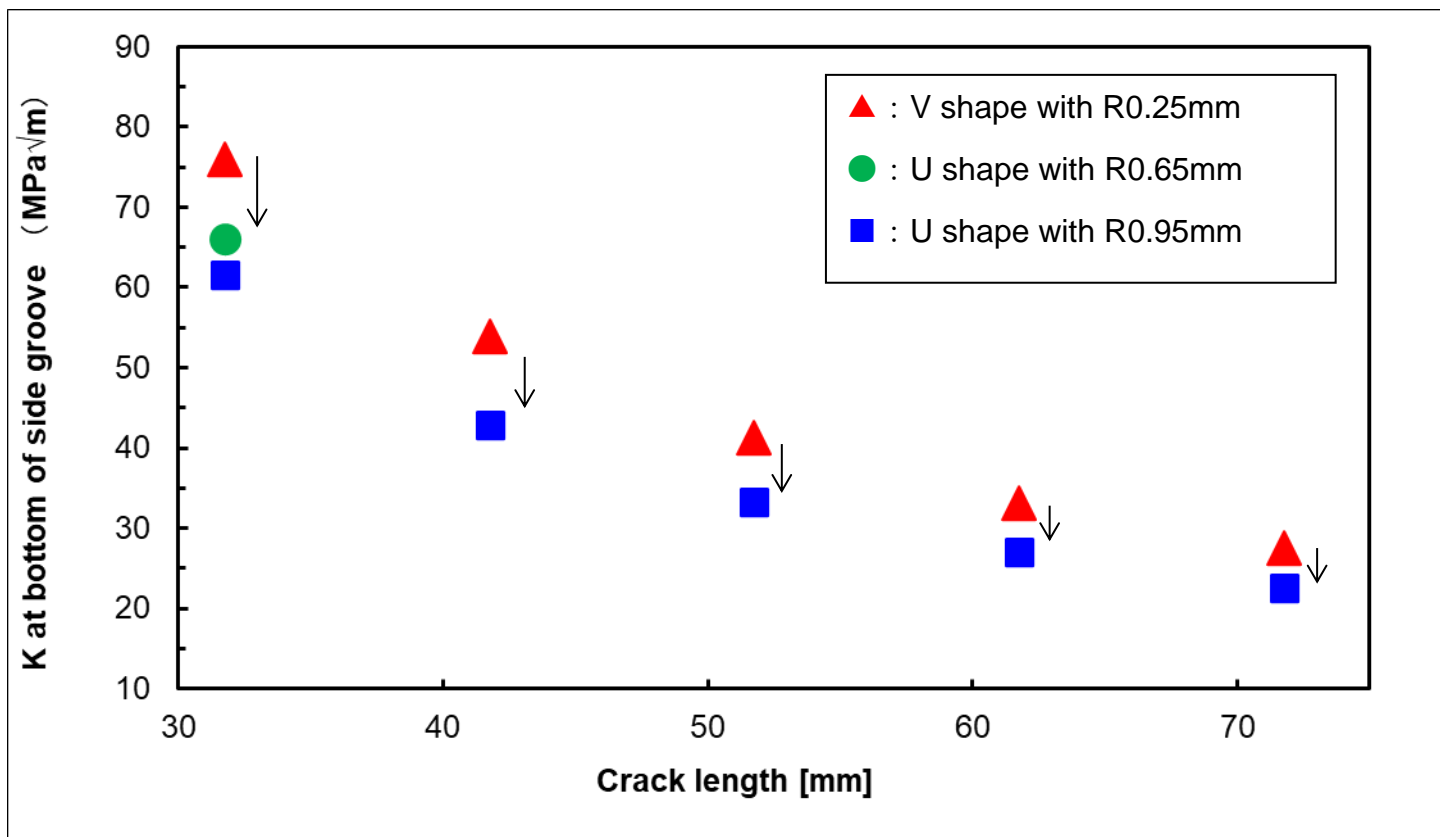
Figure 13—Variation of K distribution at bottom of the groove for direction of crack propagation

While, Figure 13 shows the distribution of K at bottom of the groove in case of (a) $\delta=0.51$ mm and (b) $\delta=0.89$ mm. At the bottom of the side groove, the U shaped grooves with R0.65mm and 0.95mm shows lower K for the crack growth direction than the standard V shaped groove with R 0.25mm.

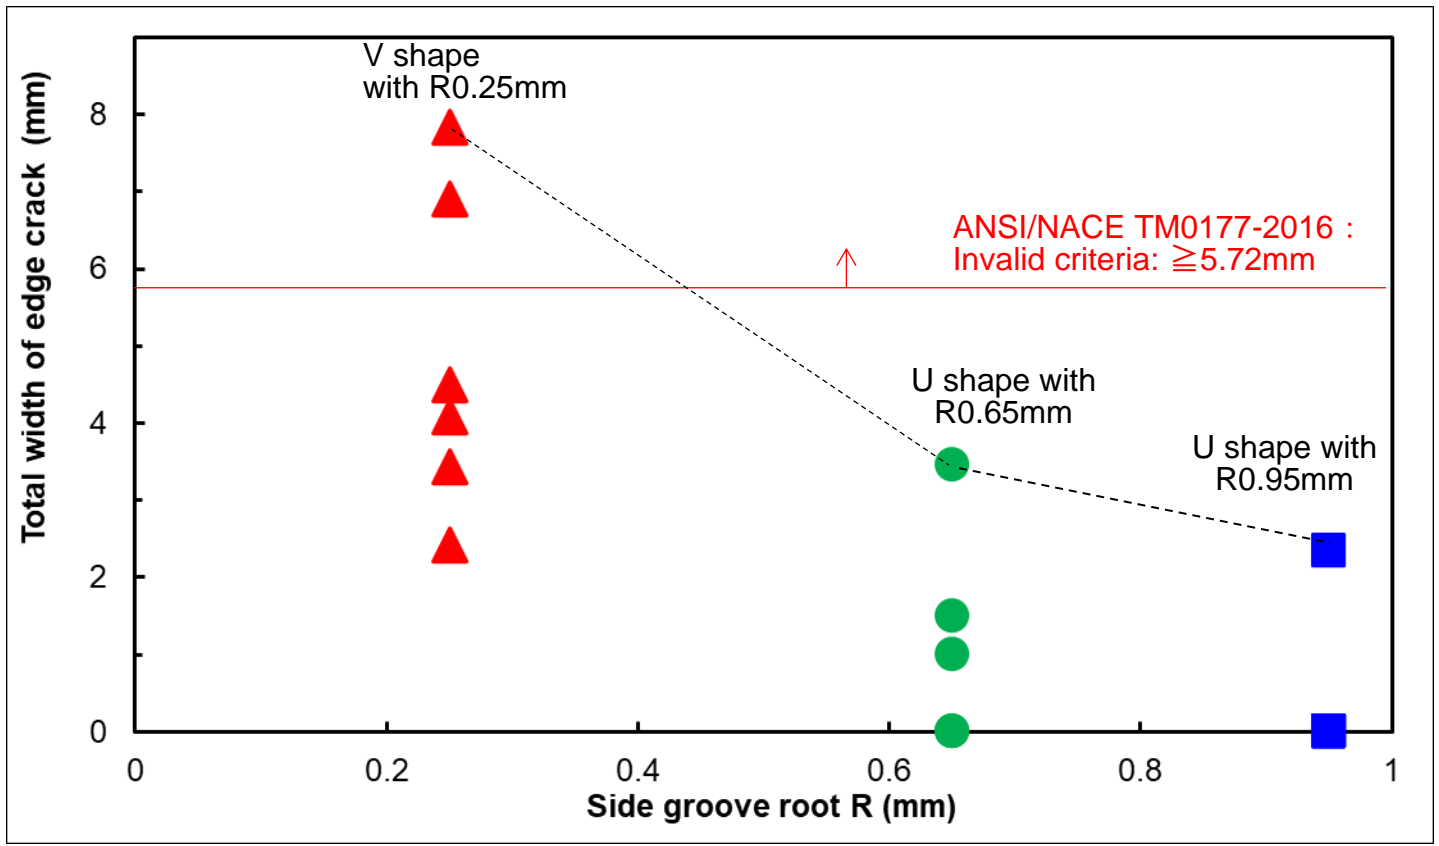
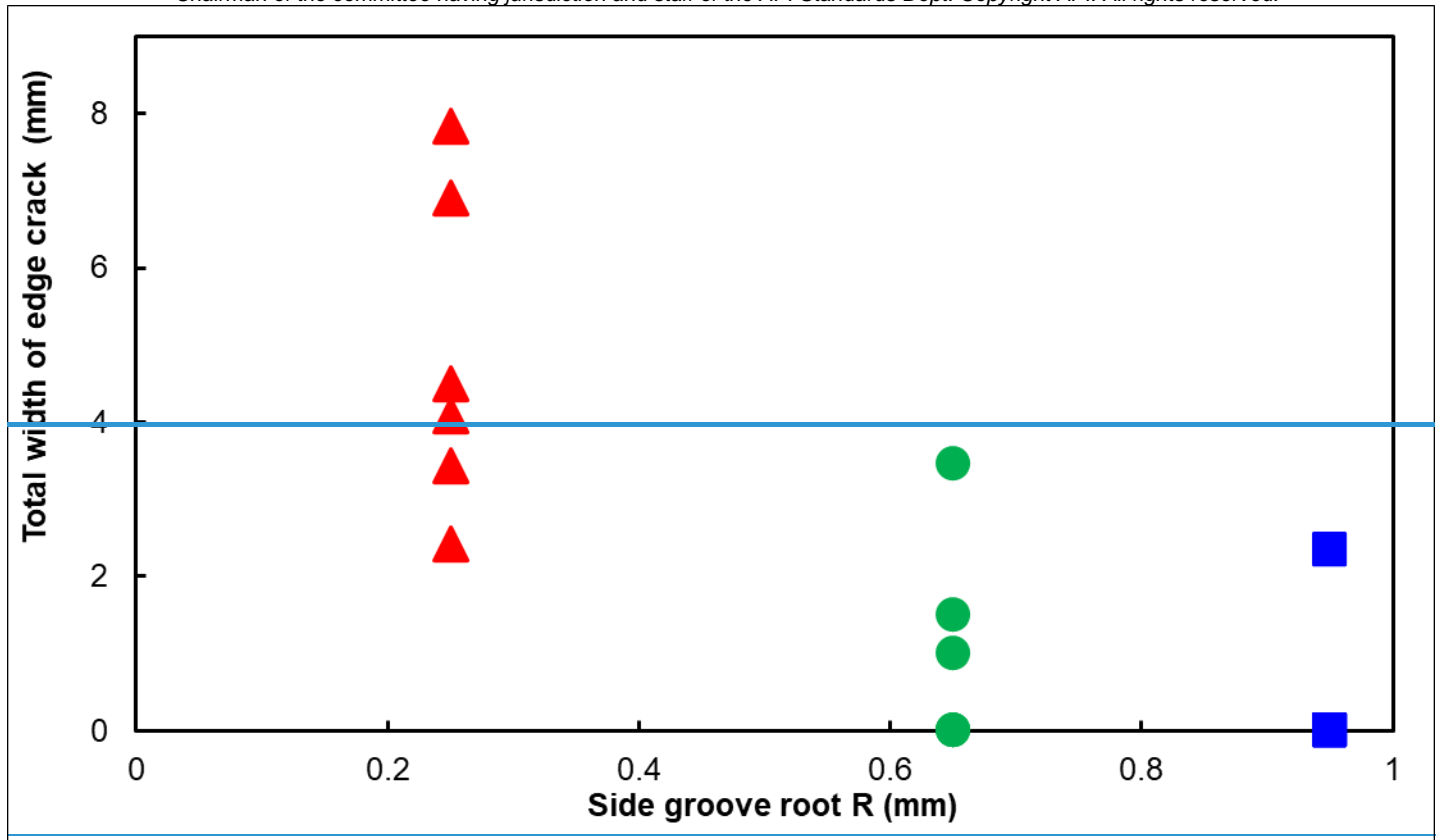
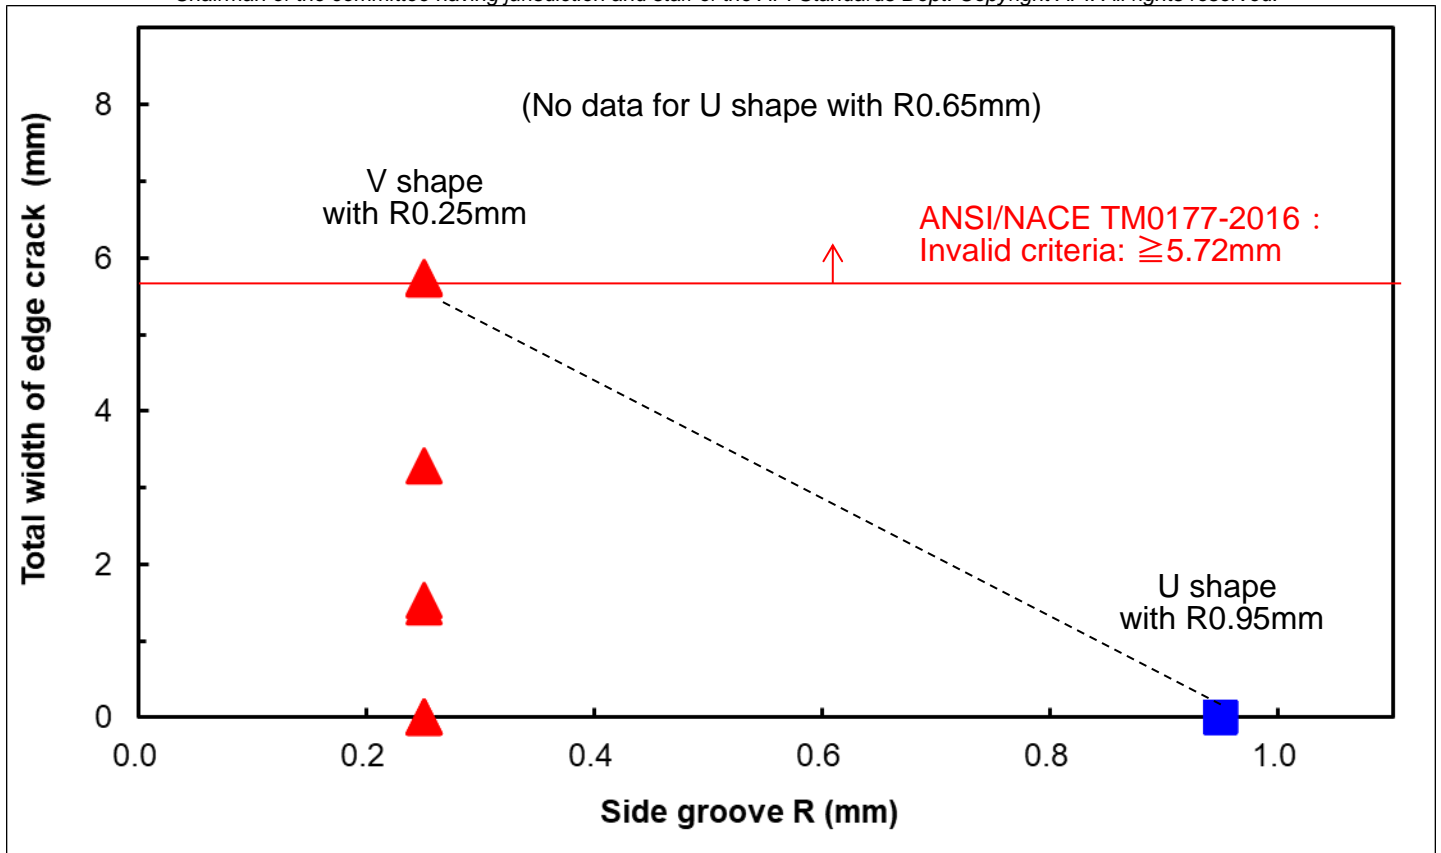
Figure 14—Comparison of total length of Edge Crack

Figure 14 shows the results of evaluating the relationship between the groove bottom root (R) and the edge crack length in the DCB test. Figure 14(a) shows the results obtained under the test condition (A) in Table 3, and Figure 14(b) shows the results obtained under the test conditions (B). In both conditions, the larger root (R), the occurrence of edge crack was suppressed. Under the test condition (A), edge crack occurred even in the specimen with the U shaped grooves with R 0.65mm and 0.95mm, but it was a minor one that was not judged as an invalid in accordance with NACE TM0177-2016 and the edge cracks were reduced compared with those in the standard V shaped side groove with R 0.25mm. Under the test condition (B), edge crack did not occur in the U shaped groove with R 0.95mm. Figure 15 shows the comparison of the $K_{I,SSC}$ values obtained using each specimens under the test conditions (A) and (B) in Table 3. Under both test conditions, there was no significant difference in the $K_{I,SSC}$ values using each test piece.

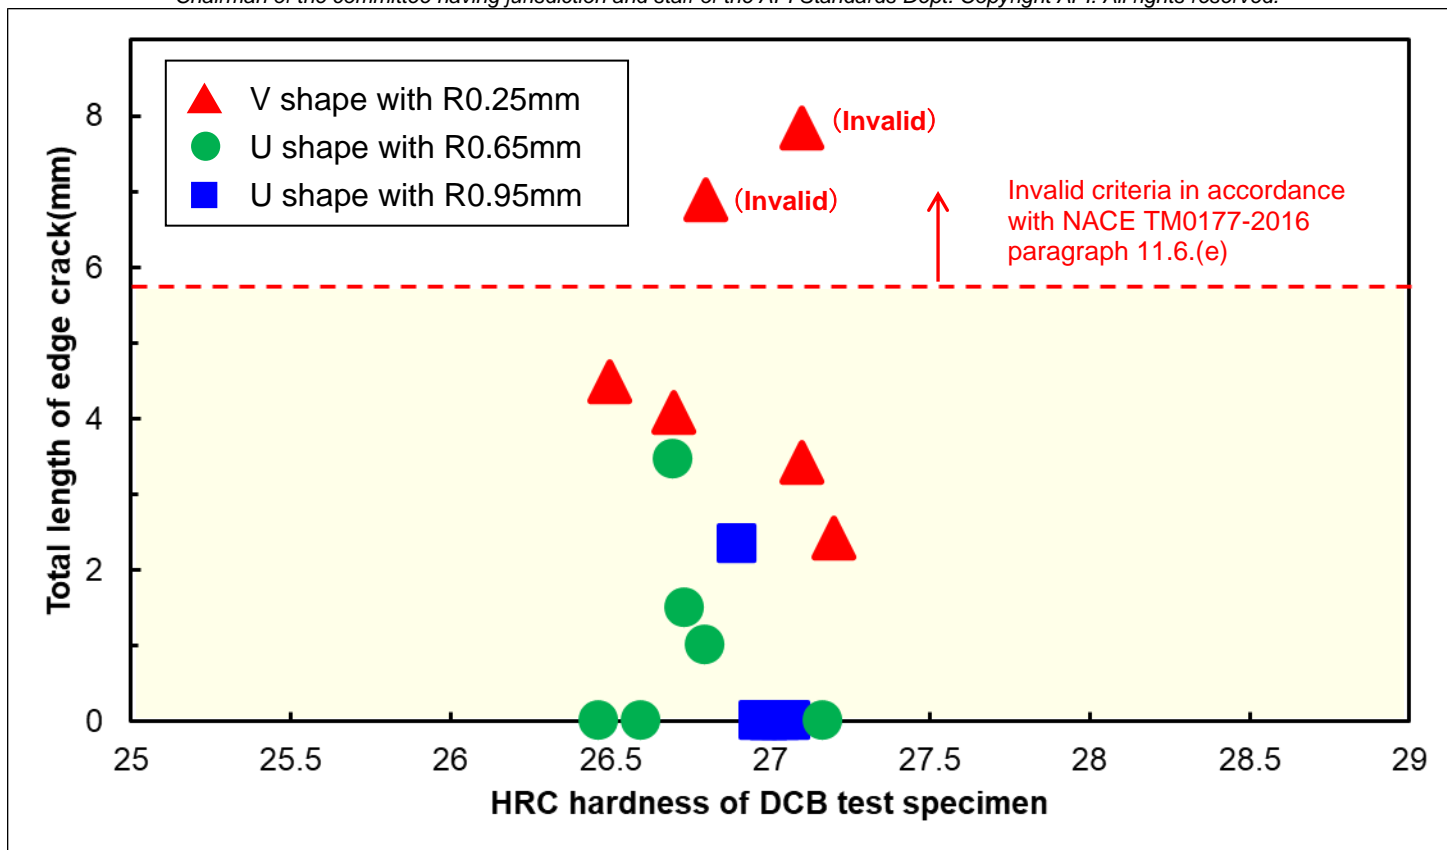
Figure16—Comparison of occurrence of edge crack

Table 8 shows the results of DCB testing for each shaped groove for C110 in 1 bar H₂S-saturated NACE Sol. A. Using those data, the occurrence of edge crack was compared in Figure 16 and Figure 17 shows the comparison of K_{ISSC} values among each shaped groove. For the standard V shaped groove with R0.25mm, the invalid results were occurred. Compared to the V shaped groove, the occurrence of edge crack was suppressed for the U shape grooves with R0.65mm and R0.95mm.

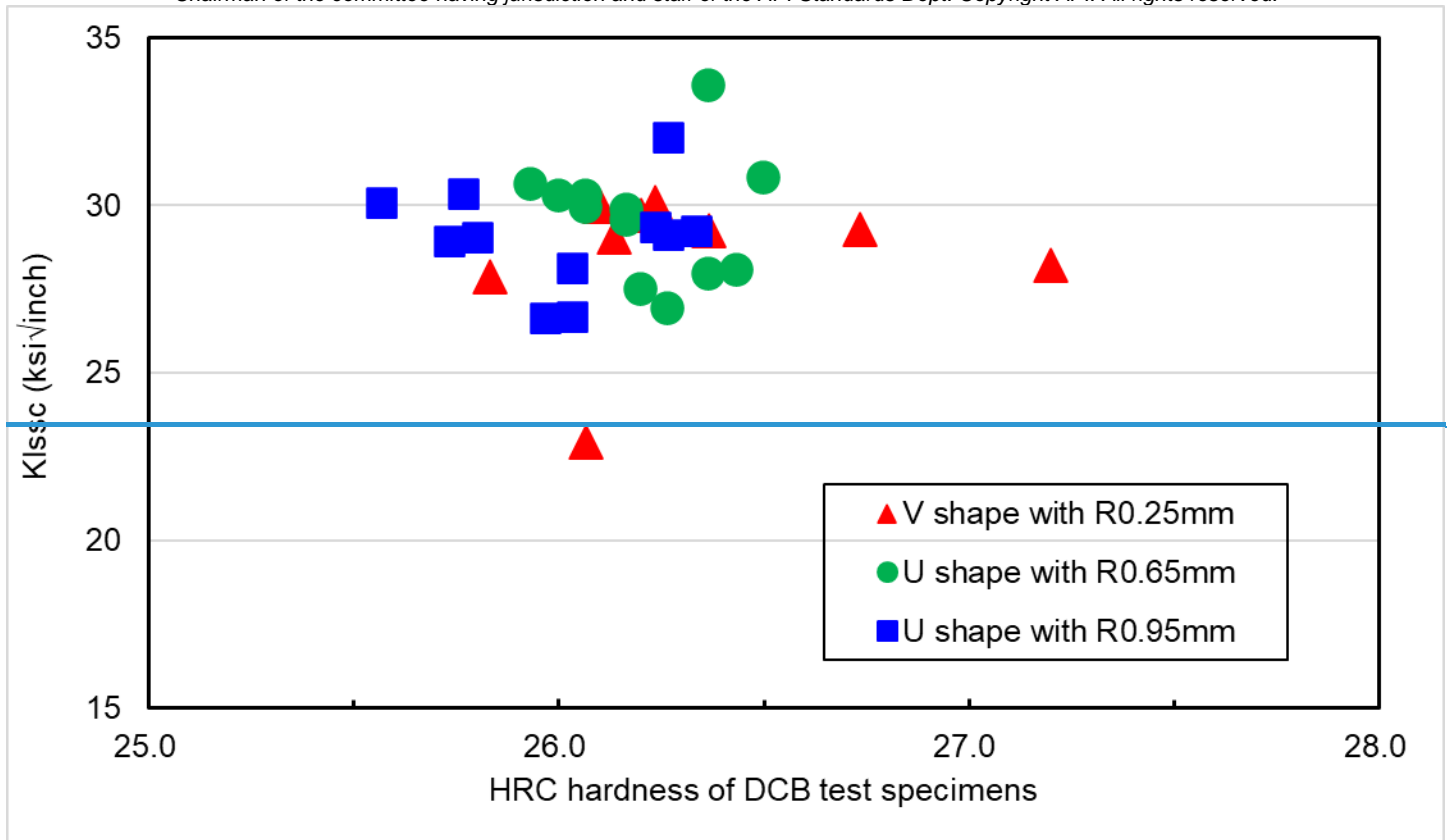
Figure 27—Comparison of $K_{I_{SSC}}$ among the different side grooves

(a) Relationship between $K_{I_{SSC}}$ and HRC hardness of DCB test specimen

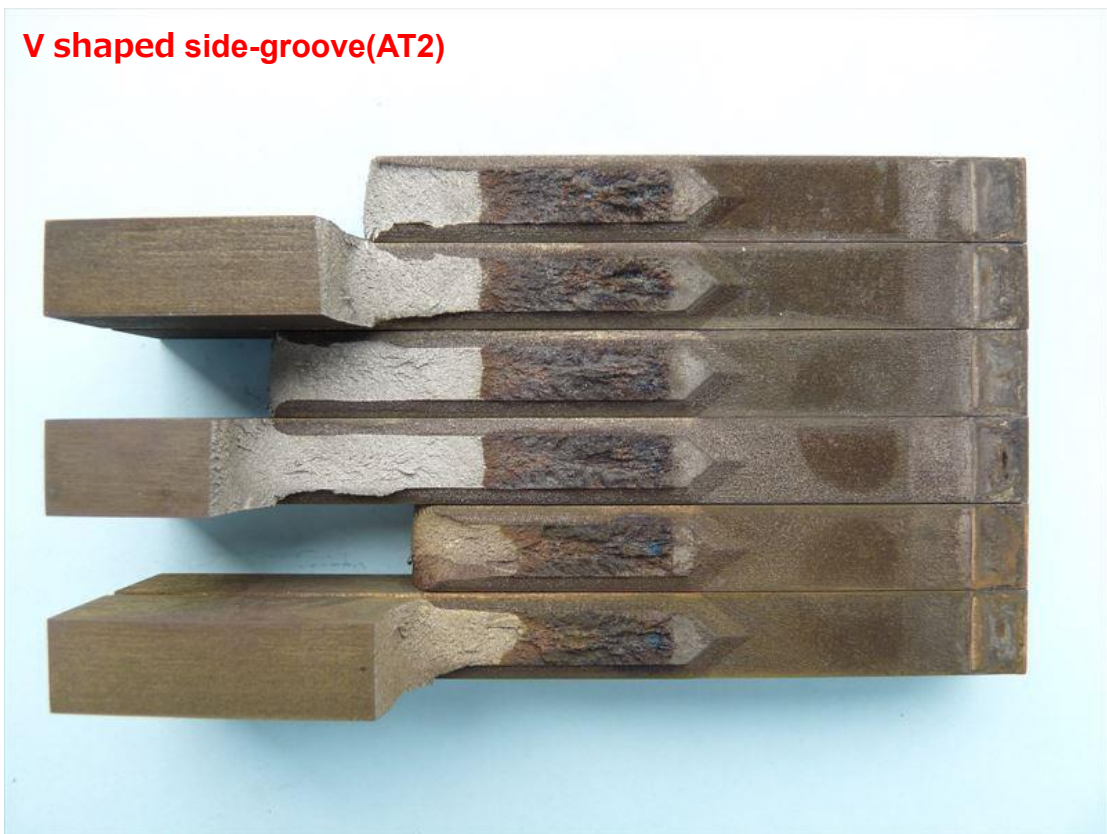
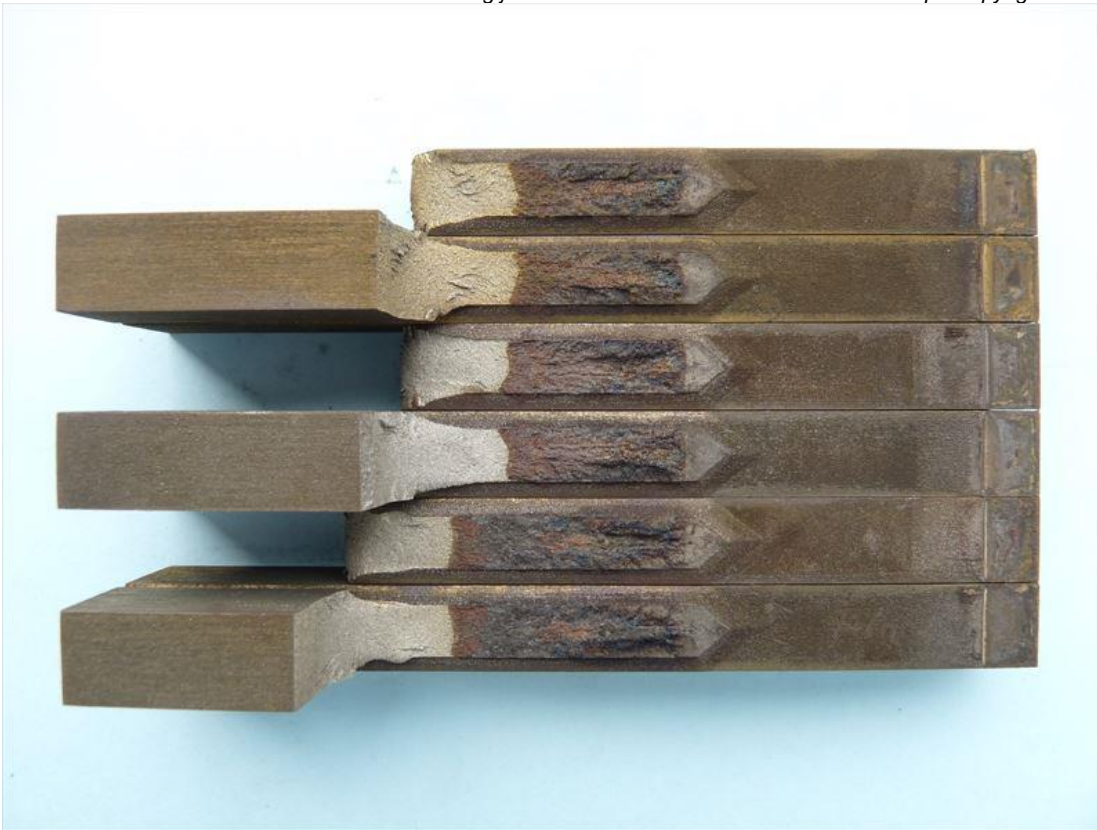
Photo 2. Fracture surface of DCB specimens with the standard V shaped groove (Mark AT2)

The fracture surfaces after DCB testing observed by microscope are shown in Photos 2 and 3. The edge crack could not be observed on the fracture surface of L80. For both the standard V shaped groove and the U shaped groove, non-planar fracture surface, which was evaluated as invalid specified in NACE TM0177 2016, occurred. There is no significant difference in the occurrence of planar surface between V shaped groove and U shaped groove. Non-planar fracture surface was observed using both the standard V shaped groove and the U shaped groove.

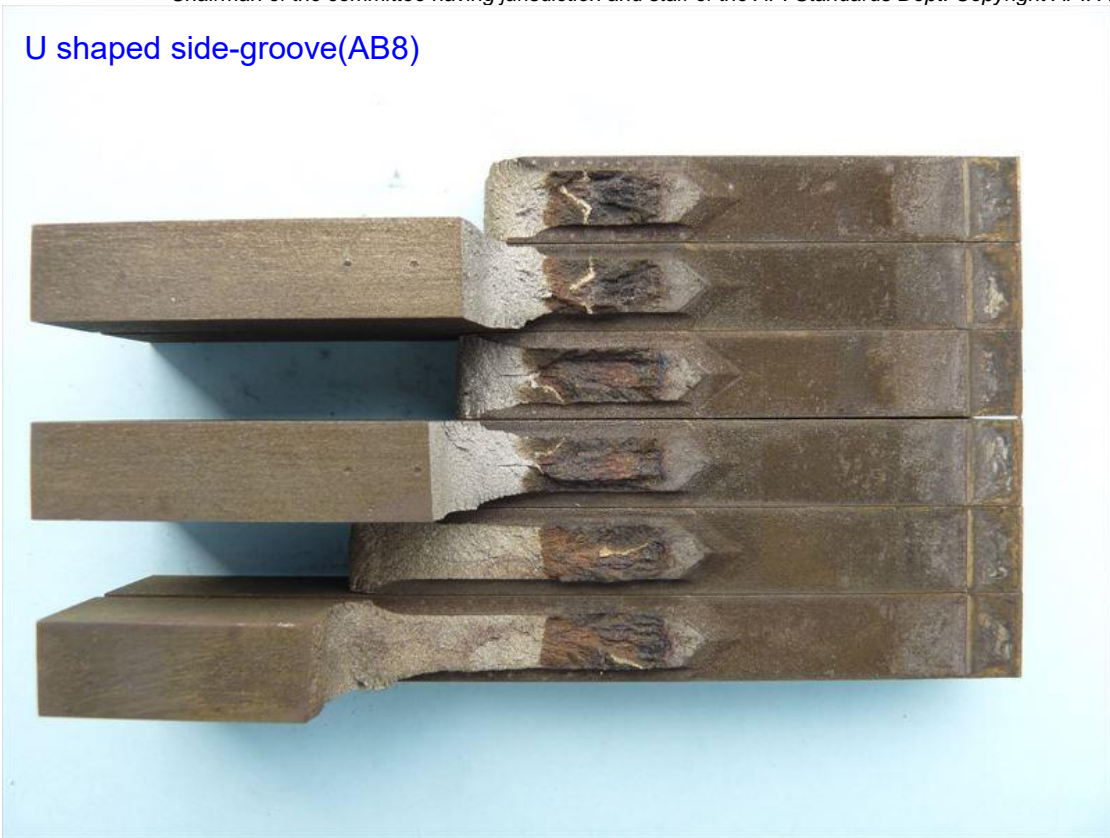
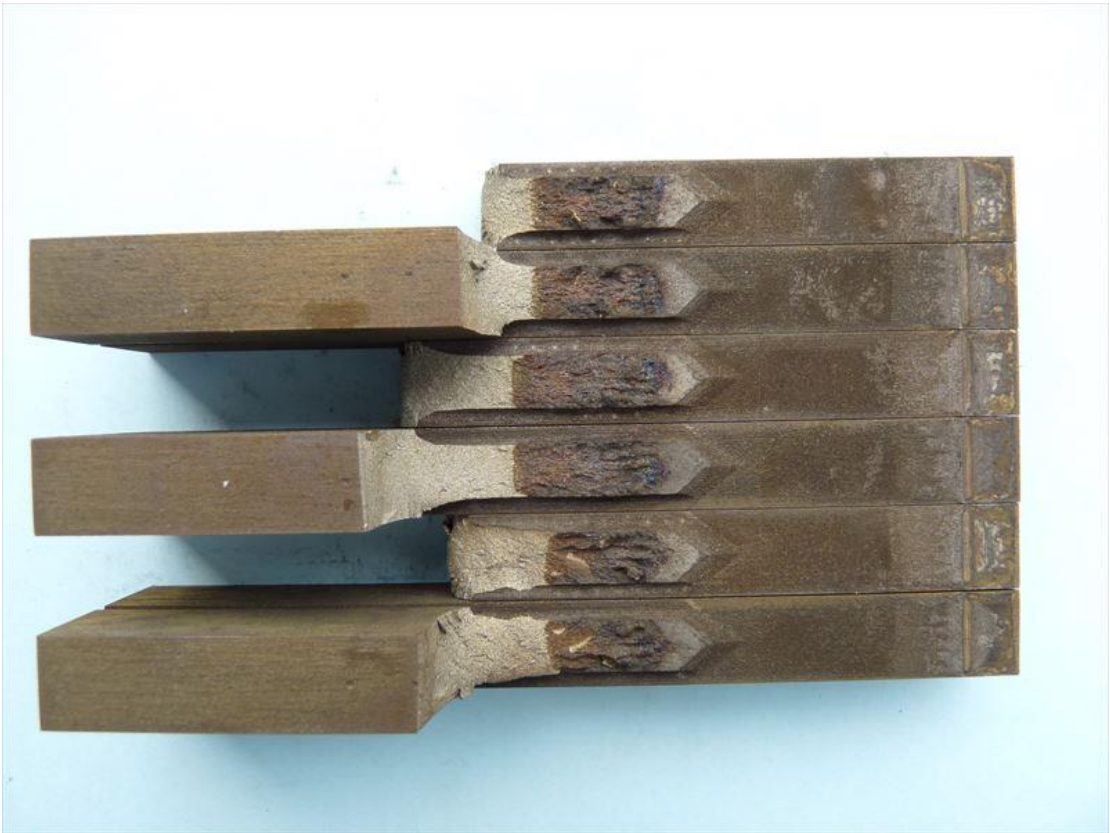
Photo 3. Fracture surface of DCB specimens with the U shaped groove (Mark AB8)

U shaped side-groove(AB8)

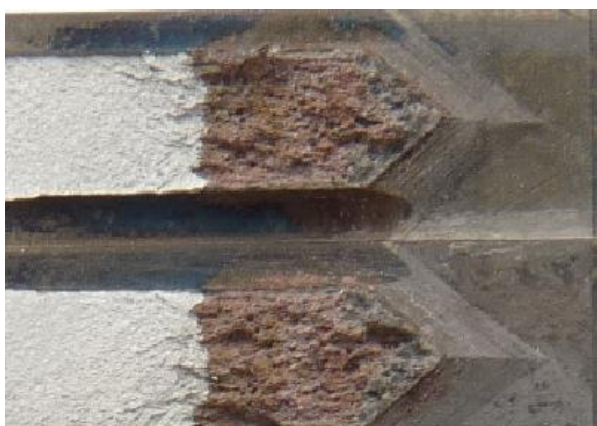
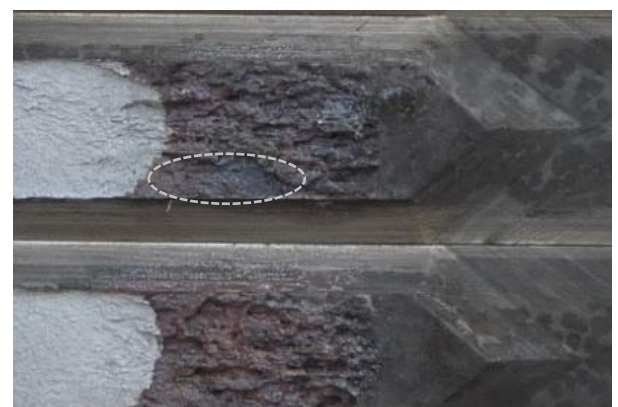
Photo 4 Example of edge cracks after tests for C110 (edge crack is surrounded by white dotted line)

As shown in Figure 35 for the specimens without pre-crack and Figure 36 for the specimens with pre-crack, the occurrence of edge crack was suppressed by using the U shaped groove with R0.95mm compared with the standard V shaped groove with R0.25mm. Example of edge cracks after tests for C110 is shown in Photo 4.

(Mark:110BV-2, V shape with R0.25mm)

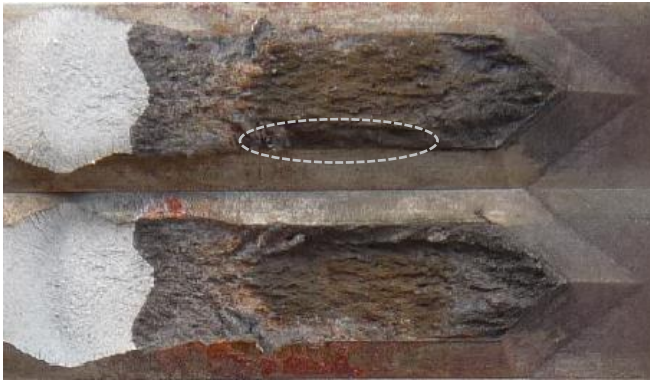
C125 (Mark:125AV-1, V shape with R0.25mm)

Photo 5 Example of edge cracks after tests for C125 (edge crack is surrounded by white dotted line)

As shown in Figure 41 for the specimens without pre-crack and Figure 42 for the specimens with pre-crack, the occurrence of edge crack was suppressed by using the U shaped groove with R0.95mm compared with the standard V shaped groove with R0.25mm. Example of edge cracks after tests is shown in Photo 5.

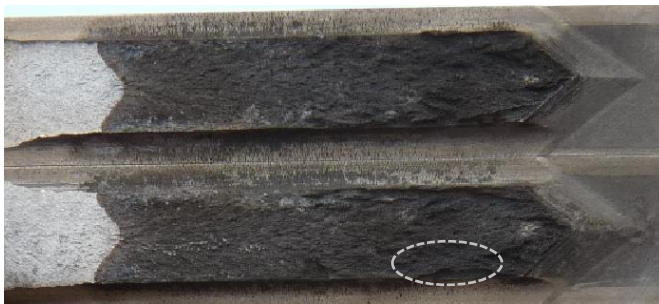
C125 (Mark: 125AU-1, U shape with R0.95mm)

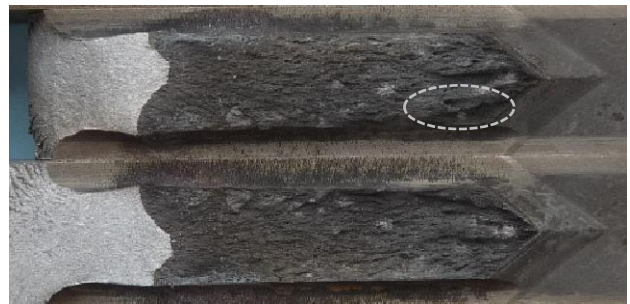
C125 (Mark:125AU-2, U shape with R0.95mm)

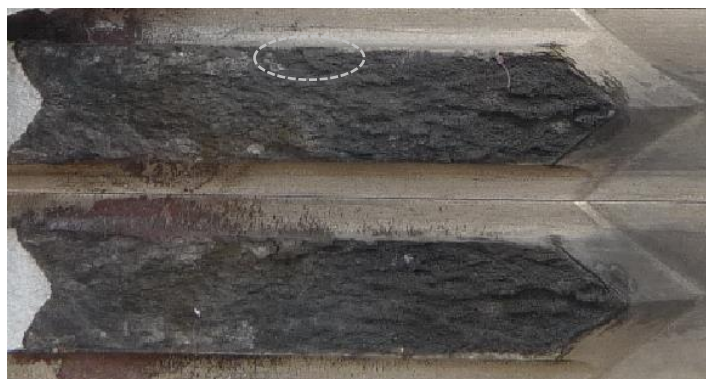
C125 (Mark:125AU-6, U shape with R0.95mm)

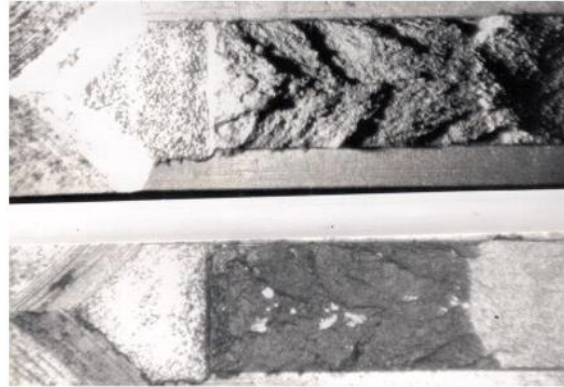
Example of edge crack revealed by low-angle illumination

Low-angle Illumination is from the left (upper) and from the right (lower).

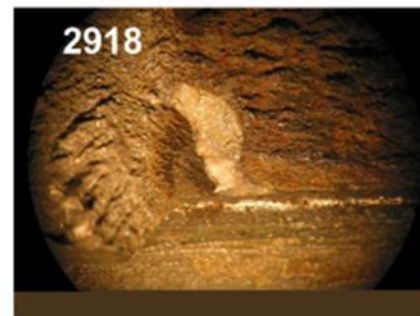
"But not every edge crack causes 'trouble' by giving false, high K_{ISSC} values. Only the ones where the broken ligament between the top and bottom arms ['Leaf Spring'] shows a significant amount of shiny, rubbed, sheared, or cleavage surface when examined for reflection under direct, bright light, should the transverse length of the leaf spring(s) be measured to see if the specimen is invalid."

Example of significant edge crack presented by one of API WI2413 (DCB side groove study) members

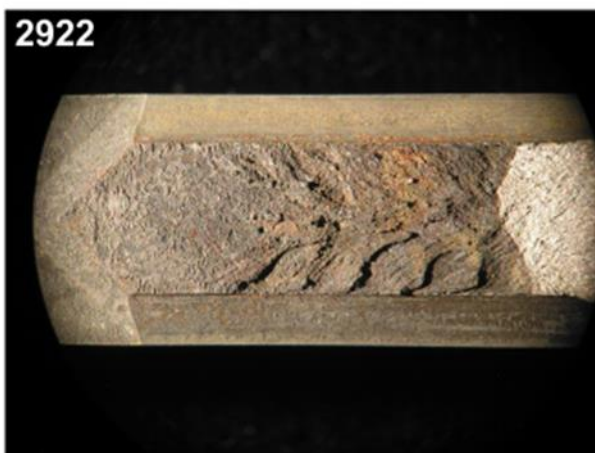
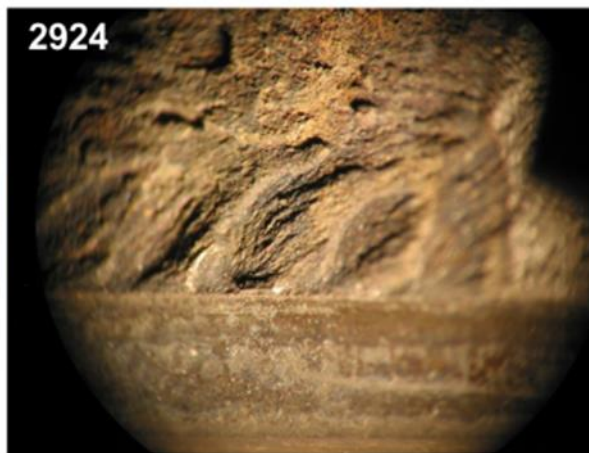
Example of insignificant edge crack presented by one of API W12413 (DCB side groove study) members

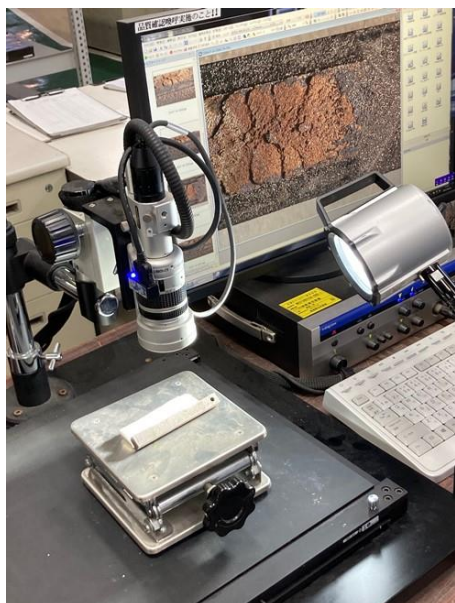
Setup in Company A

- Inspection was carried out using the setup as shown in the photo.
- Company A took pictures on the typical edge crack for each test specimen.
- Test specimens had been stored in atmospheric condition for about 1 month.

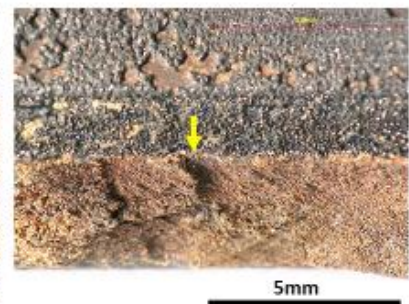
Valid test specimen in accordance with 11.6.1 e)

Validation in accordance with 11.6.1 (e)		Criteria
1	(a: Combined width of any crack front) / Bn Note: no edge cracks at crack front	Not exceed 25%
2	(b: Edge cracks lying away from the crack front that formed earlier in the test) / Bn = (b: 4.00mm) / (5.676mm) * 100 = 70.5%	Not exceed 100%
