API Ballot 6582

Work Item Number	2413
Title of Work Item	Effect of Side Groove on the Edge Cracks for Reducing Invalid Double Cantilever Beam tests
Ballot Revision Level	1
Type of Ballot (Initial, Comment, Comment resolution (reference API ballot#), 1 st Re-ballot, 2 nd Re-ballot, etc.)	Comment
Submitter Name(s)	David Sponseller, Xin Long, Keiichi Kondo
API Document Modified	TR not published yet
Impacted Documents	None (standalone TR not referenced by another API document)
Revision Key	All black text due to initial ballot for first edition TR

Effect of Side Groove on the Edge Cracks for Reducing Invalid Double Cantilever Beam tests

API TECHNICAL REPORT 5DCB
FIRST EDITION, [MONTH] [YEAR]

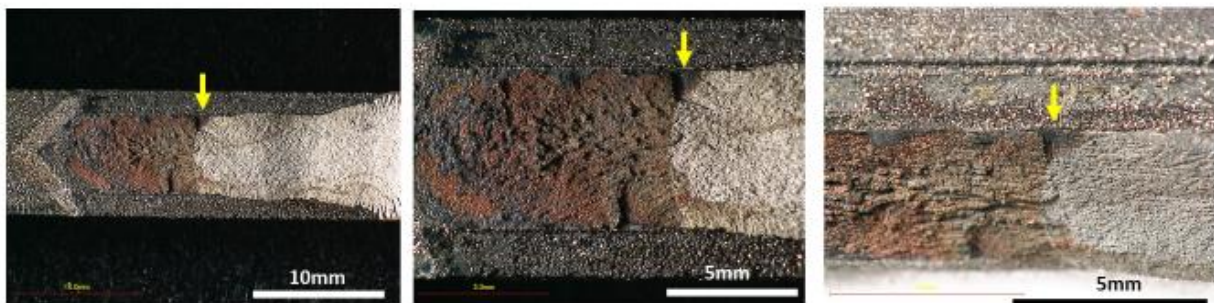
295

Invalid test specimen in accordance with 11.6.1 e) sub clause 3

Validation in accordance with 11.6.1 (e)		Criteria
1	<p>(a: Combined width of any crack front) / Bn</p> <p>= (a: 1.37mm) / (5.677mm) * 100 = 24.1%</p>	<p>Not exceed 25%</p>
2	<p>(b: Edge cracks lying away from the crack front that formed earlier in the test) / Bn</p> <p>= (b: 1.76mm) / (5.677mm) * 100 = 31.0%</p>	<p>Not exceed 100%</p>

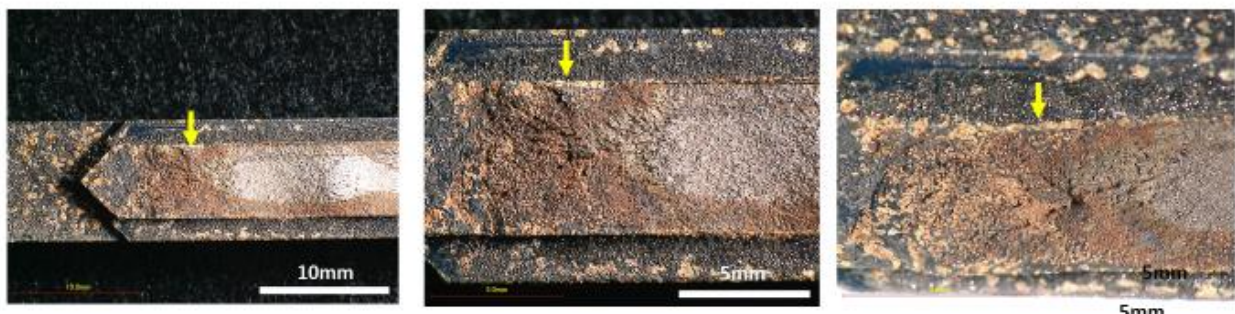
332

Valid test specimen in accordance with 11.6.1 e)

Validation in accordance with 11.6.1 (e)		Criteria
1	(a: Combined width of any crack front) / Bn Note: no edge cracks at crack front	Not exceed 25%
2	(b: Edge cracks lying away from the crack front that formed earlier in the test) / Bn = (b: 1.02mm) / (5.674mm) * 100 = 18.0%	Not exceed 100%

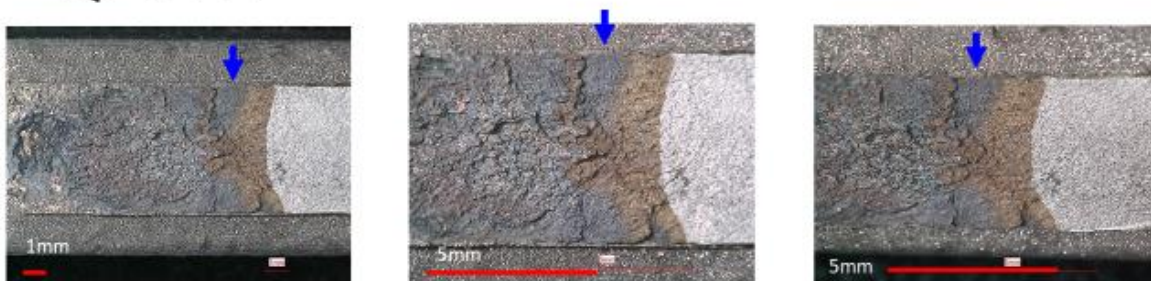
QPT1-2

Blue arrow: The representative of edge crack revealed by low-angle illumination

Validation in accordance with 11.6.1 (e)		Criteria
1	(a: Combined width of any crack front) / Bn Note: no edge cracks at crack front	Not exceed 25%
2	(b: Edge cracks lying away from the crack front that formed earlier in the test) / Bn = (b: 4.96mm) / (5.730mm) * 100 = 86.6%	Not exceed 100%

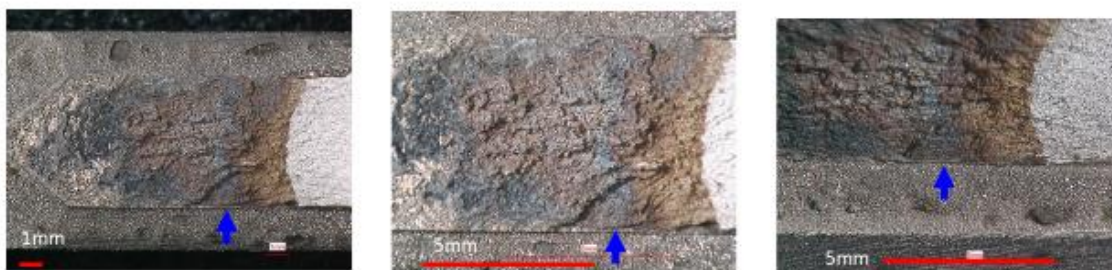
QPT1-4

Blue arrow: The representative of edge crack revealed by low-angle illumination

Validation in accordance with 11.6.1 (e)		Criteria
1	(a: Combined width of any crack front) / Bn Note: no edge cracks at crack front	Not exceed 25%
2	(b: Edge cracks lying away from the crack front that formed earlier in the test) / Bn = (b: 2.84mm) / (5.731mm) * 100 = 49.6%	Not exceed 100%

3	((b: the sum of the combined widths of the earlier-formed edge cracks) / 4 + (a: widths of those at crack front)) / Bn Note: no edge cracks at crack front	Not exceed 25%
----------	---	-------------------

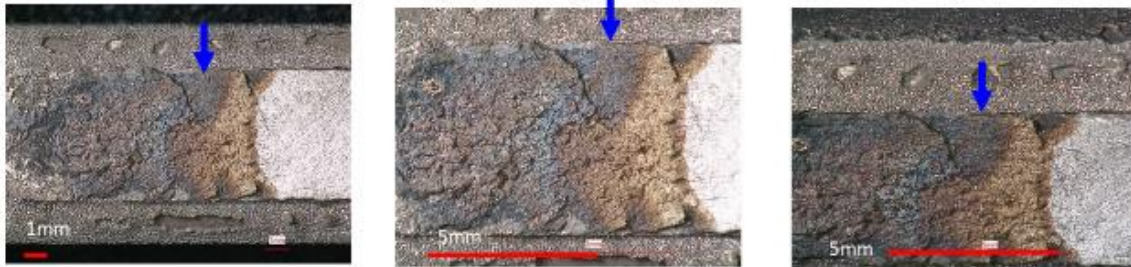
QPT1-5

Blue arrow: The representative of edge crack revealed by low-angle illumination

Validation in accordance with 11.6.1 (e)		Criteria
1	(a: Combined width of any crack front) / Bn = (a: 2.61mm) / (5.735mm) * 100 = 45.5%	Not exceed 25%
2	(b: Edge cracks lying away from the crack front that formed earlier in the test) / Bn = (b: 3.29mm) / (5.735mm) * 100 = 57.4%	Not exceed 100%
3	((b: the sum of the combined widths of the earlier-formed edge cracks) / 4 + (a: widths of those at crack front)) / Bn = ((b: 3.29mm) / 4 + (a: 2.61mm)) / (5.735mm) * 100 = 59.9 %	Not exceed 25%

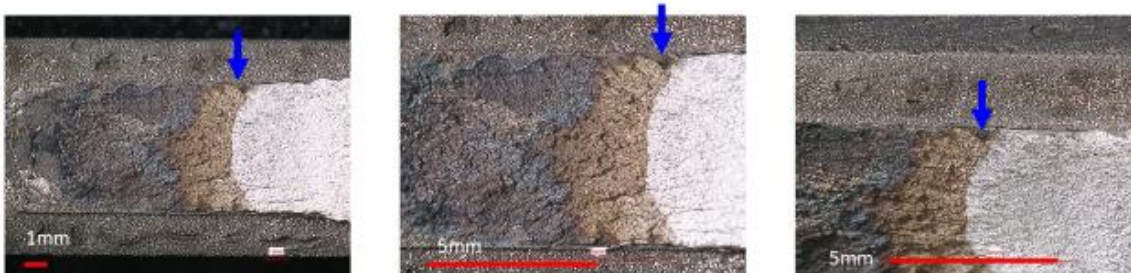
QPT1-6

Blue arrow: The representative of edge crack revealed by low-angle illumination

Validation in accordance with 11.6.1 (e)		Criteria
1	(a: Combined width of any crack front) / Bn = (a: 1.16mm) / (5.733mm) * 100 = 20.2%	Not exceed 25%
2	(b: Edge cracks lying away from the crack front that formed earlier in the test) / Bn Note: no edge cracks lying away from the crack front	Not exceed 100%

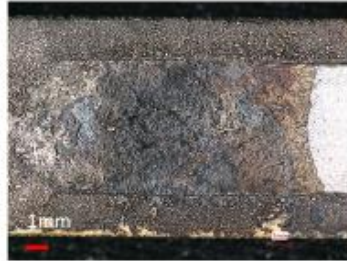
QPT1-9

Validation in accordance with 11.6.1 (e)		Criteria
1	(a: Combined width of any crack front) / Bn Note: no edge cracks at crack front	Not exceed 25%
2	(b: Edge cracks lying away from the crack front that formed earlier in the test) / Bn Note: no edge cracks lying away from the crack front	Not exceed 100%
3	((b: the sum of the combined widths of the earlier-formed edge cracks) / 4 + (a: widths of those at crack front)) / Bn Note: no edge cracks	Not exceed 25%

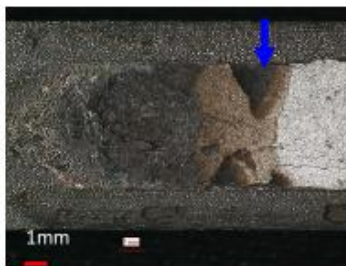
- Black dotted line: crack front line
- White dotted line: edge crack

All edge cracks was not on the crack front line. Therefore, edge cracks were calculated as the type of edge cracks lying away from the crack front.

Validation in accordance with 11.6.1 (e)		Criteria
1	(a: Combined width of any crack front) / B _n Note: no edge cracks at crack front	Not exceed 25%
2	(b: Edge cracks lying away from the crack front that formed earlier in the test) / B _n $= (b: 4.32\text{mm}) / (5.747\text{mm}) * 100 = 75.2\%$	Not exceed 100%

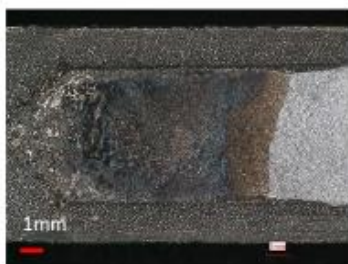
QPT2-1

Validation in accordance with 11.6.1 (e)		Criteria
1	(a: Combined width of any crack front) / Bn Note: no edge cracks at crack front	Not exceed 25%
2	(b: Edge cracks lying away from the crack front that formed earlier in the test) / Bn Note: no edge cracks lying away from the crack front	Not exceed 100%

3	$\frac{((b: \text{the sum of the combined widths of the earlier-formed edge cracks}) / 4 + (a: \text{widths of those at crack front}))}{B_n}$ <p>Note: no edge cracks</p>	Not exceed 25%
----------	--	-------------------

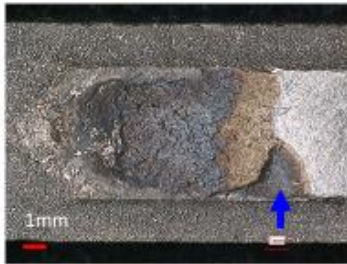
- Black dotted line: crack front line
- White dotted line: edge crack

Edge crack was not on the crack front line. Therefore, edge crack was calculated as the type of edge crack lying away from the crack front.

Validation in accordance with 11.6.1 (e)		Criteria
1	$(a: \text{Combined width of any crack front}) / B_n$ <p>Note: no edge cracks at crack front</p>	Not exceed 25%
2	$(b: \text{Edge cracks lying away from the crack front that formed earlier in the test}) / B_n$ $= (b: 2.08\text{mm}) / (5.746\text{mm}) * 100 = 36.2\%$	Not exceed 100%
3	$\frac{((b: \text{the sum of the combined widths of the earlier-formed edge cracks}) / 4 + (a: \text{widths of those at crack front}))}{B_n}$ <p>Note: no edge cracks at crack front</p>	Not exceed 25%

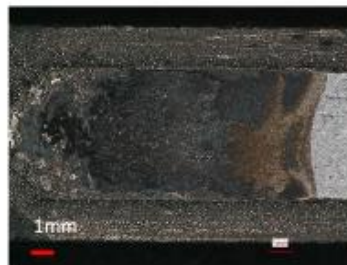
QPT2-3

Validation in accordance with 11.6.1 (e)		Criteria
1	$(a: \text{Combined width of any crack front}) / B_n$ <p>Note: no edge cracks at crack front</p>	Not exceed 25%
2	$(b: \text{Edge cracks lying away from the crack front that formed earlier in the test}) / B_n$ <p>Note: no edge cracks lying away from the crack front</p>	Not exceed 100%

3	((b: the sum of the combined widths of the earlier-formed edge cracks) / 4 + (a: widths of those at crack front)) / Bn Note: no edge cracks	Not exceed 25%
----------	--	-------------------

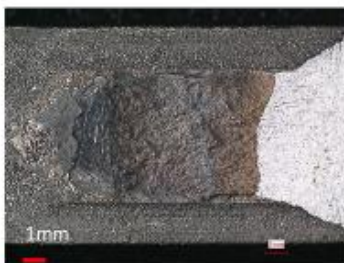
QPT2-4

Validation in accordance with 11.6.1 (e)		Criteria
1	(a: Combined width of any crack front) / Bn Note: no edge cracks at crack front	Not exceed 25%
2	(b: Edge cracks lying away from the crack front that formed earlier in the test) / Bn Note: no edge cracks lying away from the crack front	Not exceed 100%
3	((b: the sum of the combined widths of the earlier-formed edge cracks) / 4 + (a: widths of those at crack front)) / Bn Note: no edge cracks	Not exceed 25%

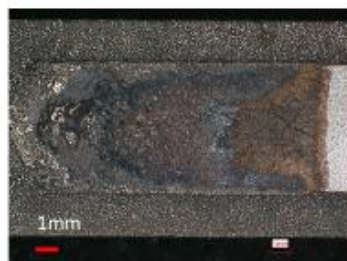
QPT2-5

Validation in accordance with 11.6.1 (e)		Criteria
1	(a: Combined width of any crack front) / Bn Note: no edge cracks at crack front	Not exceed 25%
2	(b: Edge cracks lying away from the crack front that formed earlier in the test) / Bn Note: no edge cracks lying away from the crack front	Not exceed 100%

3	((b: the sum of the combined widths of the earlier-formed edge cracks) / 4 + (a: widths of those at crack front)) / Bn Note: no edge cracks	Not exceed 25%
----------	--	-------------------

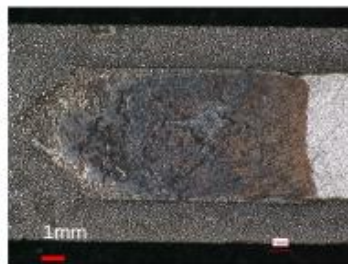
QPT2-7

Validation in accordance with 11.6.1 (e)		Criteria
1	(a: Combined width of any crack front) / Bn Note: no edge cracks at crack front	Not exceed 25%
2	(b: Edge cracks lying away from the crack front that formed earlier in the test) / Bn Note: no edge cracks lying away from the crack front	Not exceed 100%

3	((b: the sum of the combined widths of the earlier-formed edge cracks) / 4 + (a: widths of those at crack front)) / Bn Note: no edge cracks	Not exceed 25%
---	--	-------------------

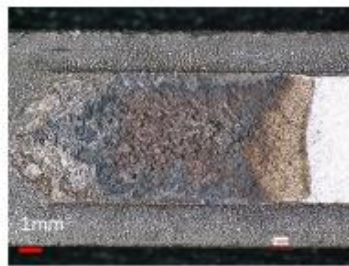
QPT2-9

Validation in accordance with 11.6.1 (e)		Criteria
1	(a: Combined width of any crack front) / Bn Note: no edge cracks at crack front	Not exceed 25%
2	(b: Edge cracks lying away from the crack front that formed earlier in the test) / Bn Note: no edge cracks lying away from the crack front	Not exceed 100%

3	$\frac{((b: \text{the sum of the combined widths of the earlier-formed edge cracks}) / 4 + (a: \text{widths of those at crack front}))}{B_n}$ <p>Note: no edge cracks</p>	Not exceed 25%
----------	--	-------------------

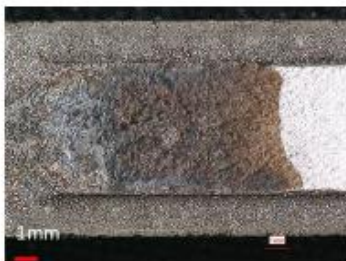
QPT2-10

Validation in accordance with 11.6.1 (e)		Criteria
1	$(a: \text{Combined width of any crack front}) / B_n$ <p>Note: no edge cracks at crack front</p>	Not exceed 25%
2	$(b: \text{Edge cracks lying away from the crack front that formed earlier in the test}) / B_n$ <p>Note: no edge cracks lying away from the crack front</p>	Not exceed 100%
3	$\frac{((b: \text{the sum of the combined widths of the earlier-formed edge cracks}) / 4 + (a: \text{widths of those at crack front}))}{B_n}$ <p>Note: no edge cracks</p>	Not exceed 25%

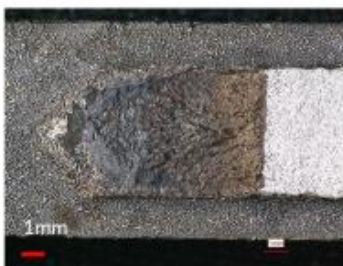
QPT2-11

Validation in accordance with 11.6.1 (e)		Criteria
1	$(a: \text{Combined width of any crack front}) / B_n$ <p>Note: no edge cracks at crack front</p>	Not exceed 25%
2	$(b: \text{Edge cracks lying away from the crack front that formed earlier in the test}) / B_n$ <p>Note: no edge cracks lying away from the crack front</p>	Not exceed 100%

3	((b: the sum of the combined widths of the earlier-formed edge cracks) / 4 + (a: widths of those at crack front)) / Bn Note: no edge cracks	Not exceed 25%
---	--	-------------------

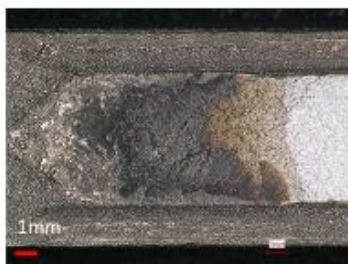
QPT3-1

Validation in accordance with 11.6.1 (e)		Criteria
1	(a: Combined width of any crack front) / Bn Note: no edge cracks at crack front	Not exceed 25%
2	(b: Edge cracks lying away from the crack front that formed earlier in the test) / Bn Note: no edge cracks lying away from the crack front	Not exceed 100%
3	((b: the sum of the combined widths of the earlier-formed edge cracks) / 4 + (a: widths of those at crack front)) / Bn Note: no edge cracks	Not exceed 25%

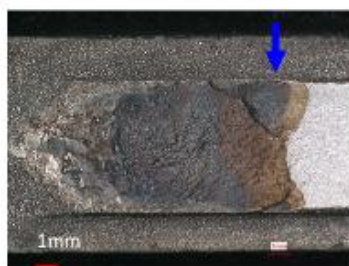
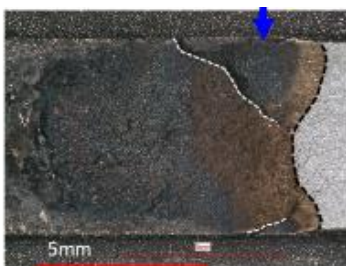
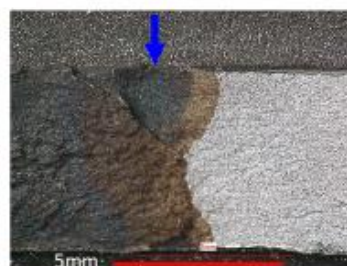
QPT3-2

Blue arrow: The representative of edge crack revealed by low-angle illumination

- Black dotted line: crack front line
- White dotted line: edge crack

Edge cracks was not on the crack front line. Therefore, edge cracks were calculated as the type of edge cracks lying away from the crack front.

Validation in accordance with 11.6.1 (e)		Criteria
1	(a: Combined width of any crack front) / Bn Note: no edge cracks at crack front	Not exceed 25%

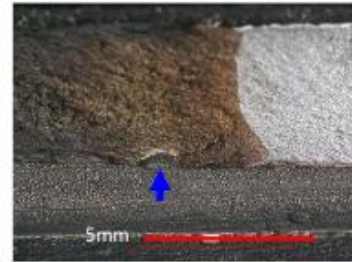
QPT3-3

Blue arrow: The representative of edge crack revealed by low-angle illumination

Validation in accordance with 11.6.1 (e)		Criteria
1	(a: Combined width of any crack front) / Bn Note: no edge cracks at crack front	Not exceed 25%
2	(b: Edge cracks lying away from the crack front that formed earlier in the test) / Bn = (b: 0.79mm) / (5.752mm) * 100 = 13.7%	Not exceed 100%
3	((b: the sum of the combined widths of the earlier-formed edge cracks) / 4 + (a: widths of those at crack front)) / Bn Note: no edge cracks at crack front	Not exceed 25%

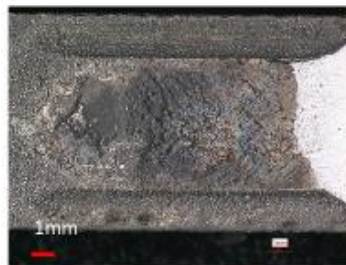
QPT3-4

Validation in accordance with 11.6.1 (e)		Criteria
1	(a: Combined width of any crack front) / Bn Note: no edge cracks at crack front	Not exceed 25%
2	(b: Edge cracks lying away from the crack front that formed earlier in the test) / Bn Note: no edge cracks lying away from the crack front	Not exceed 100%

3	((b: the sum of the combined widths of the earlier-formed edge cracks) / 4 + (a: widths of those at crack front)) / Bn Note: no edge cracks	Not exceed 25%
----------	--	-------------------

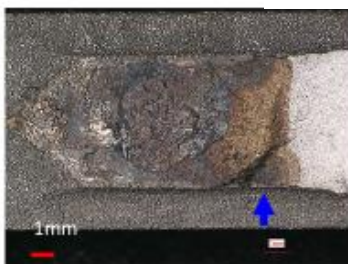
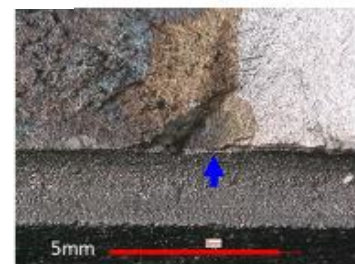
Blue arrow: The representative of edge crack revealed by low-angle illumination

- Black dotted line: crack front line
- White dotted line: edge crack

Edge crack was on the crack front line.

Validation in accordance with 11.6.1 (e)		Criteria
1	(a: Combined width of any crack front) / Bn = (a: 2.14mm) / (5.751mm) * 100 = 37.2%	Not exceed 25%

2	(b: Edge cracks lying away from the crack front that formed earlier in the test) / Bn Note: no edge cracks lying away from the crack front	Not exceed 100%
3	((b: the sum of the combined widths of the earlier-formed edge cracks) / 4 + (a: widths of those at crack front)) / Bn Note: no edge cracks lying away from the crack front	Not exceed 25%

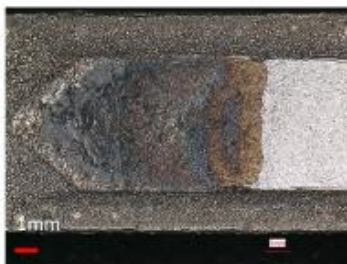
QPT3-7

Validation in accordance with 11.6.1 (e)		Criteria
1	(a: Combined width of any crack front) / Bn Note: no edge cracks at crack front	Not exceed 25%
2	(b: Edge cracks lying away from the crack front that formed earlier in the test) / Bn Note: no edge cracks lying away from the crack front	Not exceed 100%
3	((b: the sum of the combined widths of the earlier-formed edge cracks) / 4 + (a: widths of those at crack front)) / Bn Note: no edge cracks	Not exceed 25%

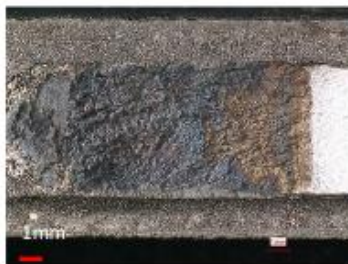
QPT3-8

Validation in accordance with 11.6.1 (e)		Criteria
--	--	----------

1	(a: Combined width of any crack front) / Bn Note: no edge cracks at crack front	Not exceed 25%
2	(b: Edge cracks lying away from the crack front that formed earlier in the test) / Bn Note: no edge cracks lying away from the crack front	Not exceed 100%
3	((b: the sum of the combined widths of the earlier-formed edge cracks) / 4 + (a: widths of those at crack front)) / Bn Note: no edge cracks	Not exceed 25%

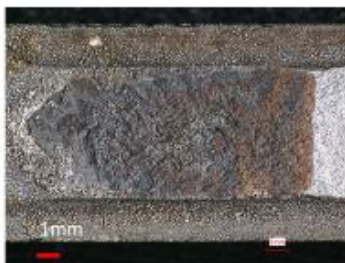
QPT3-9

Validation in accordance with 11.6.1 (e)		Criteria
1	(a: Combined width of any crack front) / Bn Note: no edge cracks at crack front	Not exceed 25%
2	(b: Edge cracks lying away from the crack front that formed earlier in the test) / Bn Note: no edge cracks lying away from the crack front	Not exceed 100%
3	((b: the sum of the combined widths of the earlier-formed edge cracks) / 4 + (a: widths of those at crack front)) / Bn Note: no edge cracks	Not exceed 25%

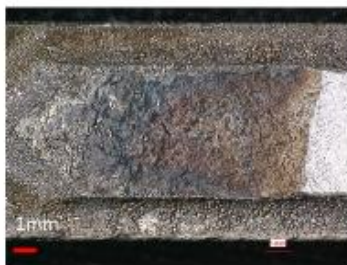
QPT3-10

Validation in accordance with 11.6.1 (e)		Criteria
1	(a: Combined width of any crack front) / Bn Note: no edge cracks at crack front	Not exceed 25%

2	(b: Edge cracks lying away from the crack front that formed earlier in the test) / Bn Note: no edge cracks lying away from the crack front	Not exceed 100%
3	((b: the sum of the combined widths of the earlier-formed edge cracks) / 4 + (a: widths of those at crack front)) / Bn Note: no edge cracks	Not exceed 25%

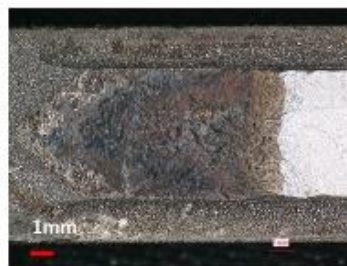
QPT3-12

Validation in accordance with 11.6.1 (e)	Criteria
--	----------

1	(a: Combined width of any crack front) / Bn Note: no edge cracks at crack front	Not exceed 25%
2	(b: Edge cracks lying away from the crack front that formed earlier in the test) / Bn Note: no edge cracks lying away from the crack front	Not exceed 100%
3	((b: the sum of the combined widths of the earlier-formed edge cracks) / 4 + (a: widths of those at crack front)) / Bn Note: no edge cracks	Not exceed 25%
