Inspection for High Temperature Hydrogen Attack

API RECOMMENDED PRACTICE 586, Section 2

FIRST EDITION, TBD 2022

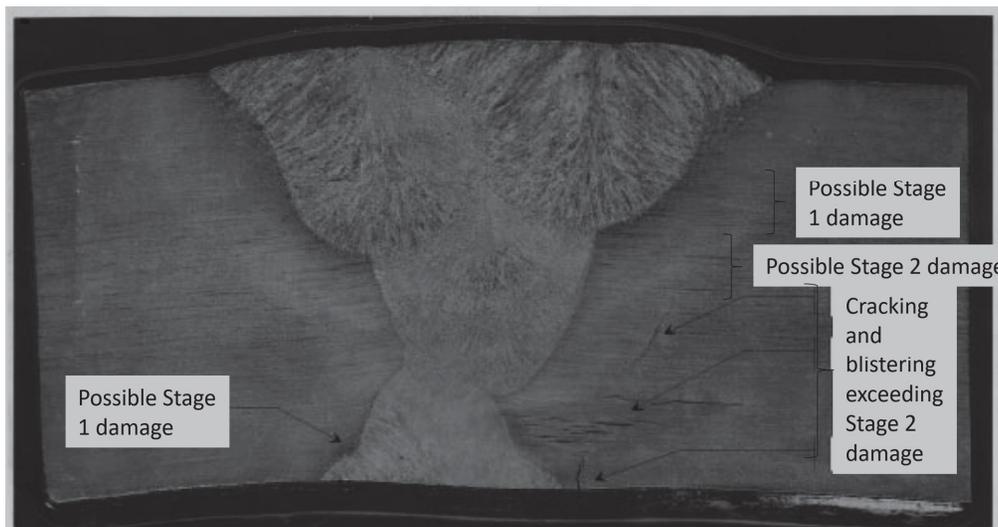
Figure 4—HTHA Combination of Volumetric, Blister, and Crack-like Flaw Damage Manifestation.

4. HTHA Combination of Volumetric, Blister, and Crack-like Flaw Damage—Volumetric damage can occur to the base metal while crack-like flaws are occurring within the HAZ of welds (See Figure 4). Volumetric damage that occurs ahead of the crack tip can weaken the nearby material, leading to even faster crack growth rates. Proposed UT characterization/categorization/reporting acronym—(CVBC). Note that it is also possible to have volumetric and crack-like flaws without necessarily having blisters. In advance of the cracking, it is possible to have Stage 2 damage, which is usually detectable by NDE, and Stage 1 damage, which is usually not detectable by NDE.

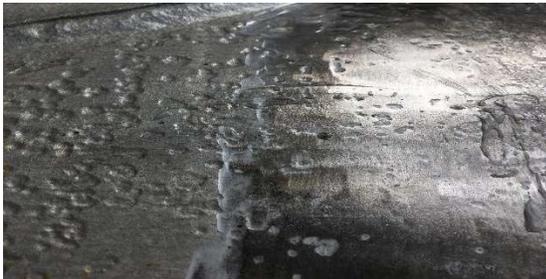
Figure B2. Surface before grinding (left) and after grinding before grit finish (right).

For reasons of expediency, grit blasting and grinding tend to be the first choices. Grinding however, leaves behind surfaces that are not conducive to effective HTHA inspections that are dependent on higher ultrasonic frequencies, and are to be avoided if possible.

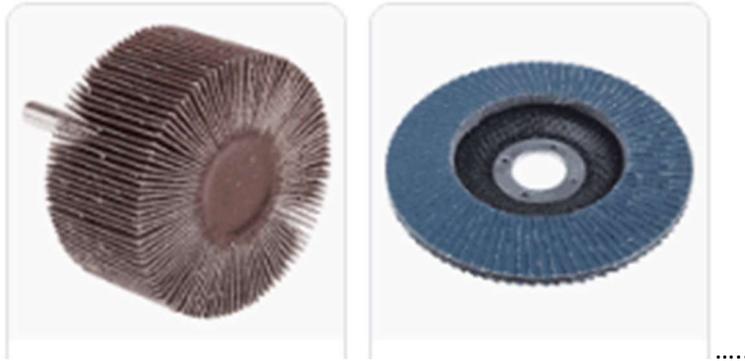
Figure B3. Grit finishes can be achieved using flapper disc or wheel.

- The preferred method for pre-cleaning is using a sand-blast finish.
- Surface preparation by grinding should be used as a last resort. If surfaces are pre-cleaned by grinding, care must be taken to retain a smooth and even surface.
- Surfaces to be inspected with 5MHz probe frequencies may be finished to a wire brush or sandblast finish.
- Surfaces to be inspected with 10MHz probe frequencies require finishing to an 80-grit finish.
- Surfaces to be inspected with 15MHz probe frequencies require finishing to a 120 grit finish.

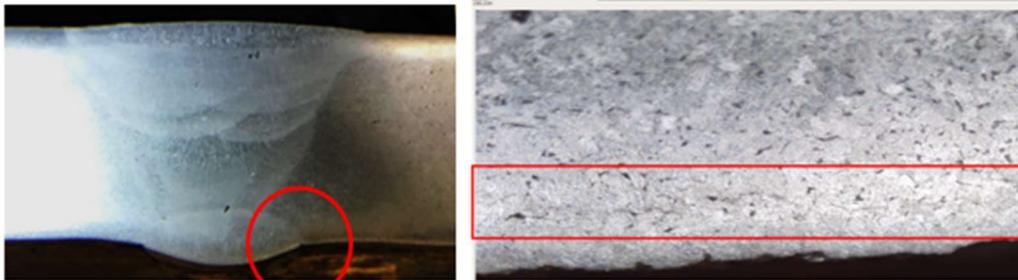
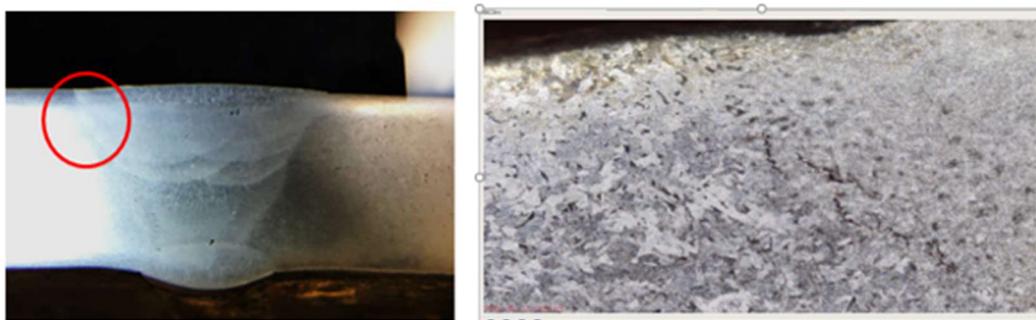
Example B3 - 28mm thick reactor.

Figure B6. Confirmed Decarburization and Fissuring: (a) at ID; (b) at OD (TOFD - top and optical metallography - bottom). Reprinted with permission from Sonomatic.
