Agenda Item:		650-1092
Title:	Backing Bar Foundation Notches	
Date:	November 13 th , 2020	
Contact:	Name:	Doug Bayles, PE
	Company:	Hagen Engineering International
	Phone:	(918) 973-3502
	E-mail:	doug@hagenengineering.com
Purpose:	Inquiry INQ-650-D125 requested clarification as to whether a notch is required in a concrete ringwall or slab so that the backing bar does not come into contact with the concrete.	
Source:	INQ-650-D125	
Revision:	2	
Impact:	The business impact of this item is minimal, but would require foundation contractors to do additional forming during construction so that notches in the foundation will not support the back up bar, but will support the bottom plates.	
Rationale:	<p>Although not addressed in the main body of API 653, Annex E – Section E.7.1.c specifically states for Self-Anchored tanks that are subject to seismic loading, uniform support of the tank bottom shall be provided by a)..., b)... or c) Using double butt-welded bottom or annular plates resting directly on the foundation. Annular plates or bottom plates under the shell may utilize back-up bar welds if the foundation is notched to prevent the back-up bar from bearing on the foundation.</p> <p>Ma

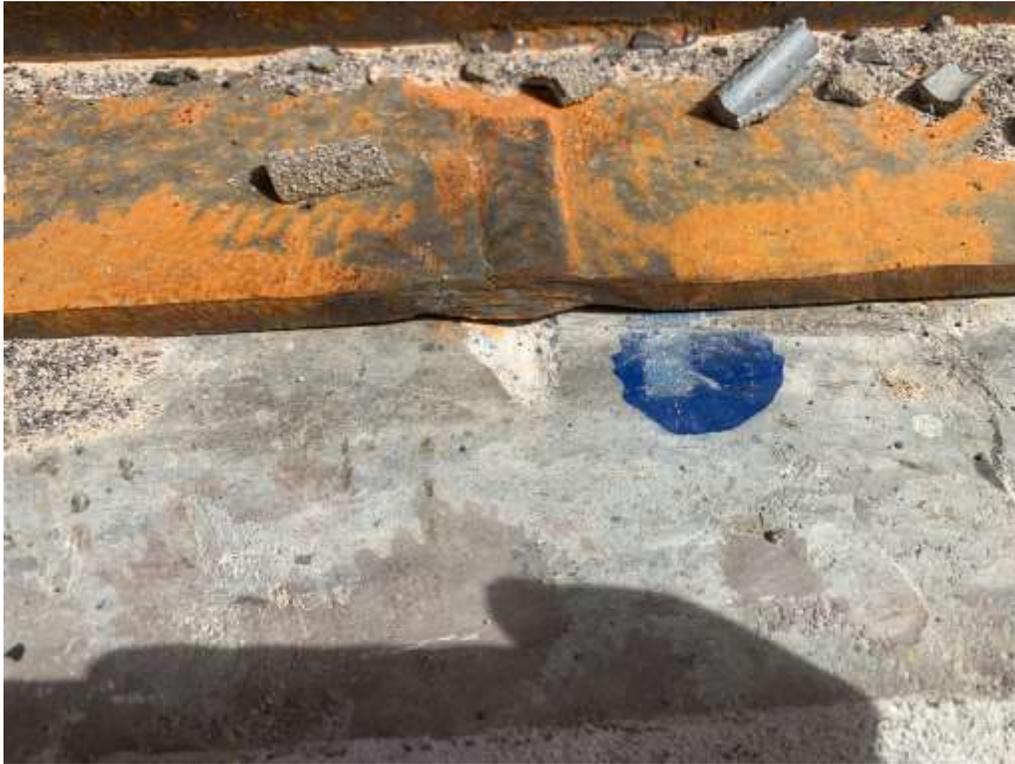
Figure 1 - Photograph shows a back up bar resting on a foundation without notches. This shows the groove that developed during construction due to thermal expansion and contraction.

Note: Per E.7.1, the bottom plates under the tank shell are to be provided with a uniformly supported annulus. Per E.7.1 c), consideration for notching of the top of the concrete for radial butt welded tank bottom plates or annular plates should be considered, when utilizing back up bars. If a notch is utilized, the notch shall be equal to the depth of the back-up bar and the width plus 1/4" to allow for installation tolerances. If notches are not utilized for lap welded bottoms, annular bottoms with back up bars and double butt welded bottoms (with minimal reinforcing on the bottom side), grooves can develop on the top of the concrete due to expansion and contraction. After the groove develops a "lip" near the outer edge, the bottom edges of the tank bottom can impart a load on the outside of the groove. These outward radial load can cause cracking or spalling of the tank foundation.

Complete butt welded tank bottoms with non-radial back up bars should use grout or other suitable material to provide uniform support with consideration for forces resulting from thermal expansion of the tank bottom, in lieu of notches.

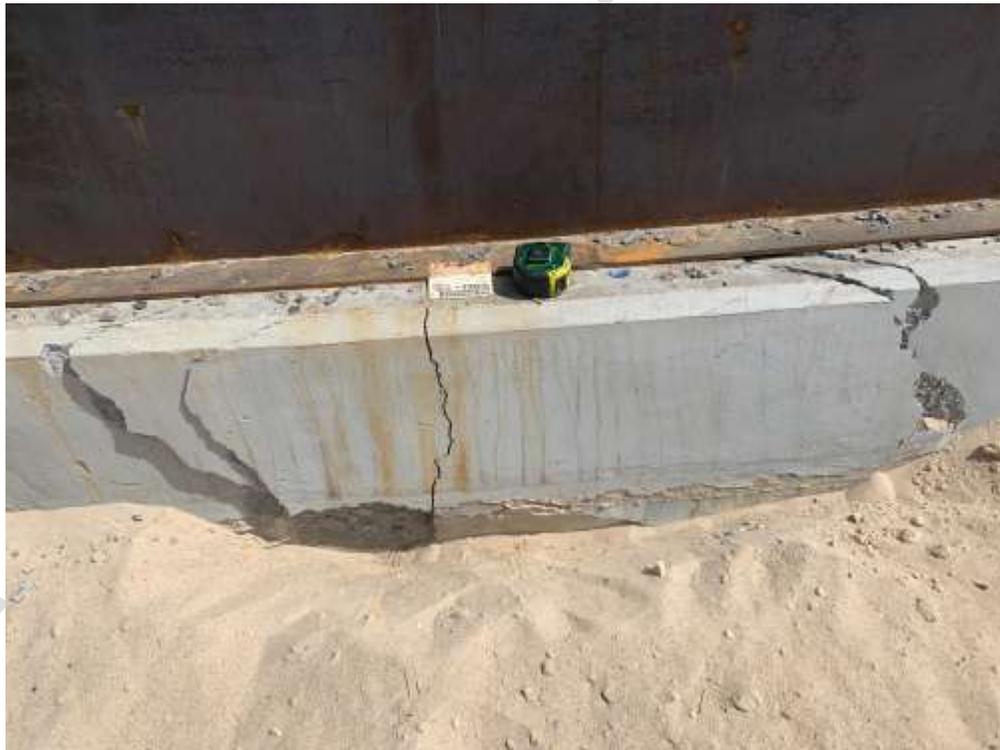
Figure 2- This photograph shows the result of not having the ringwall notched. The groove worn during construction caused outside edge of the back-up bar to "catch" and when the bottom/tank expanded, it caused a lateral loading on the top of the ringwall, thus spalling a large area.
