# API RP 572 Inspection Practices for Pressure Vessels

## Annex B (informative) - Towers

### Towers

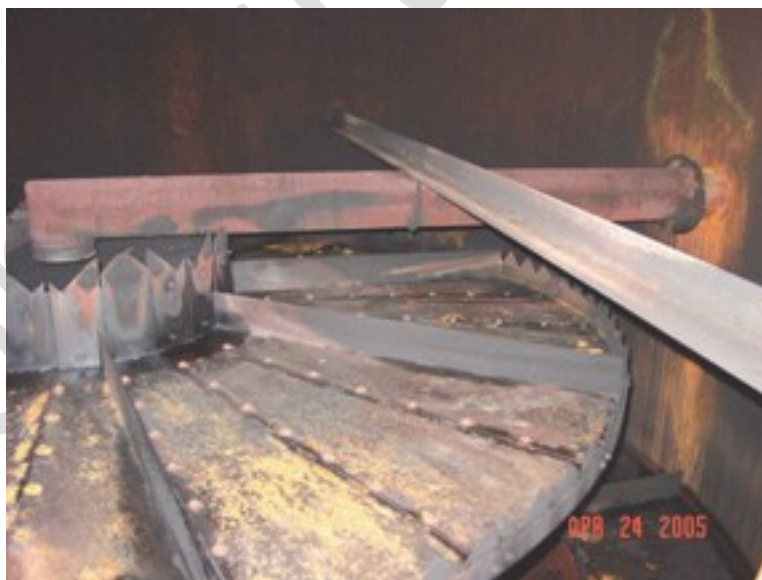
Figure B.1 - Disk/Donut Tray

The two common types of cascade trays are shed trays and disk/donut trays. Cascade trays utilize a different approach to gas/liquid contact than regular trays. Shed trays may be anything from angle iron to half pipes. Large numbers of shed trays are arranged in rows, installed perpendicular to each other and to the gas and liquid flow such that breakup of the falling liquid takes place. Gas flow up through the droplets of liquid is the primary source of contact for mass transfer. In disk/donut trays (see Figure B.1) the disks and donuts are installed in alternating sequence, with the donuts mounted to the shell and the disks suspended in the center of the tower, with both the disks and the donuts being perpendicular to the gas and liquid flow. As liquid repeatedly cascades from the disks to the donuts, sheeting and breakup of the liquid takes place.

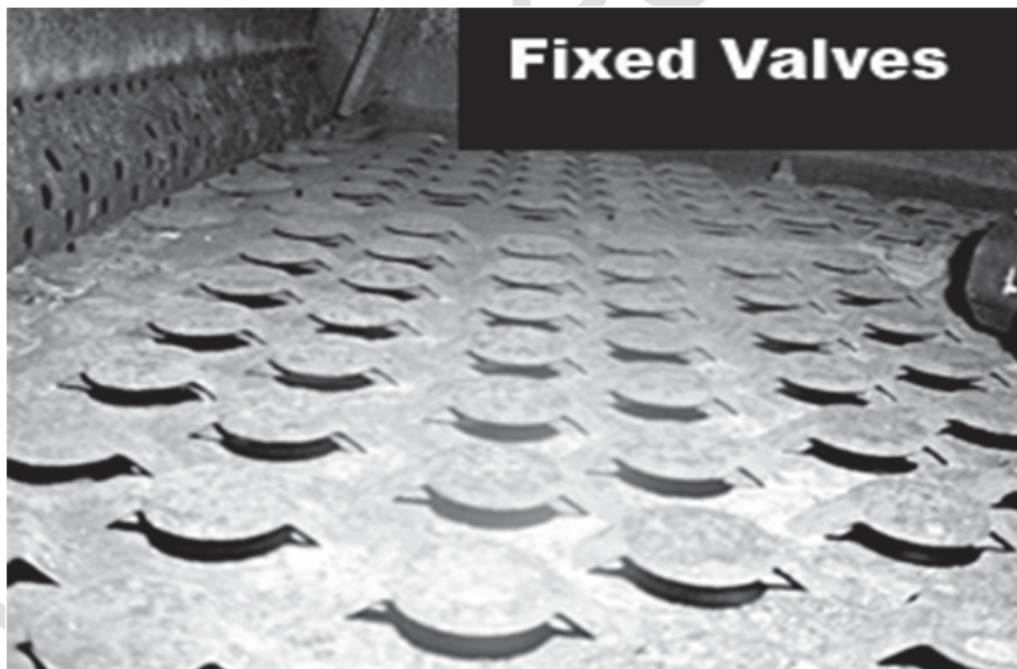
Figure B.7 - Fixed Valves

While operating ranges are less than those allowed by moveable valve trays, significant increases in operating ranges and efficiency over sieve trays and bubble cap trays are possible using fixed valves extruded from the tray decks. Fixed valves offer lateral gas flow to inhibit fouling rather than the vertical gas flow of sieve trays, and higher mechanical strength than floating valve trays, with no moving parts to wear out.

Newer fixed valve designs offer even greater operating ranges, efficiency, and fouling resistance but at the cost of losing the single-piece construction of the extruded valves and at the cost of additional wear as valve tabs loosen or corrode.

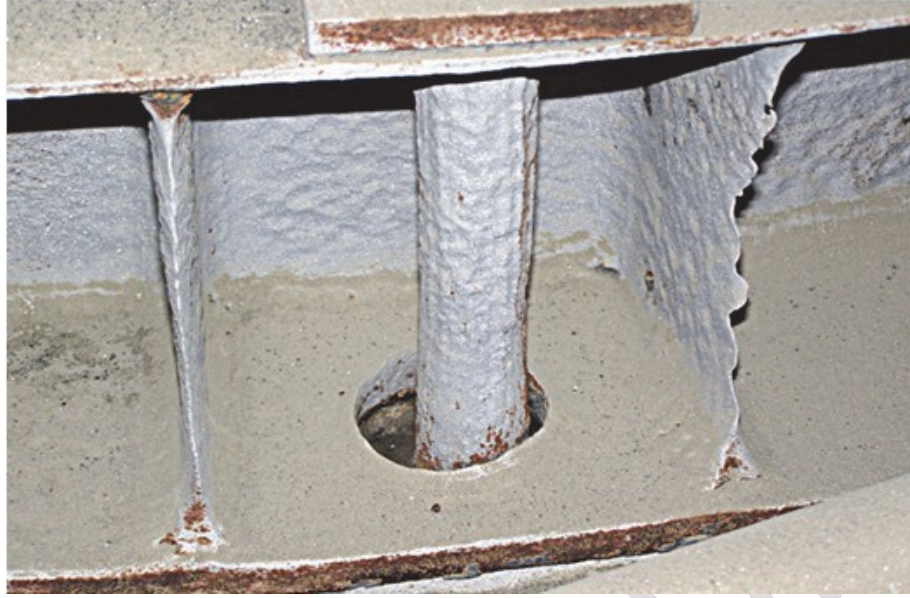
Figure B.17 - Corroded Anchor Bolting

**The Anchor Bolts**—Due to the leverage applied by the height of the tower and the corrosion masking effect of fireproofing, particular care should be taken when inspecting the anchor bolting of towers (see Figure B.17 and Figure B.18).

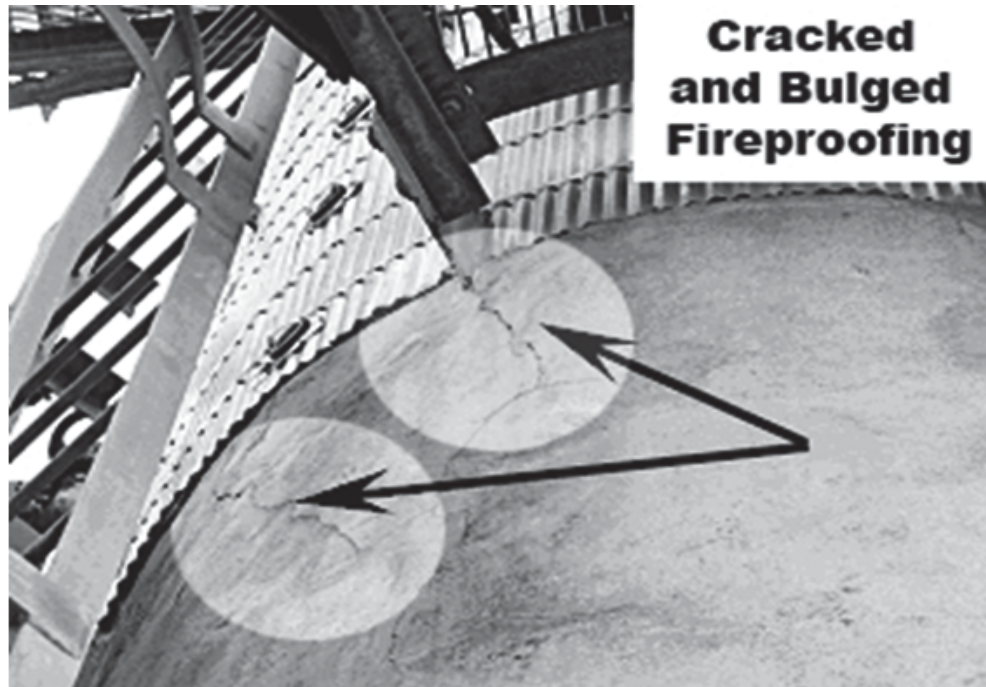
Figure B.19 - Cracked and Bulged Fireproofing

Any crack over 0.250 in. (6.4 mm) in width, and any crack that has displacement or bulging of the concrete fireproofing material should be investigated for CUF. Identifying CUF, as with CUI, is a primary focus of today's mechanical integrity programs. Figure B.19 shows cracks within a tower's fireproofing.

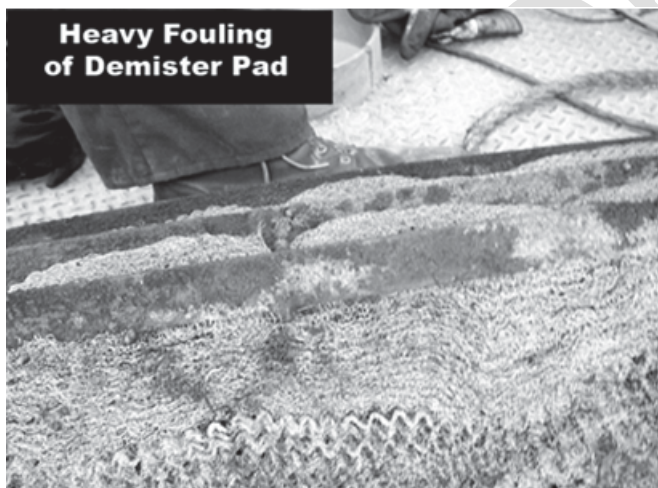
Figure B.31 - Fouled Demister Pads

Normal visual inspection and quantification of the surface texture and corrosion present on the top head and shell course may be supplemented with UT thickness measurements. Thickness measurements of susceptible areas or areas of visible impingement should be taken in conjunction with the visual inspection throughout the tower. Such areas of impingement can frequently be found above demister pads, and are indicative of pad bypass, usually due to improper installation or breakdown within the pad. If internal UT thickness measurements are to be taken subsequent to the visual inspection, identification and high-visibility marking of the areas where measurements are to be taken is of great importance. Figure B.30 to Figure B.32 gives examples of fouled demister pads and identify internal UT thickness measurement locations.

When not removed by inspection scope, demister pad installation defects warrant removal when indicative of demister bypass, damage to the pads or retention grid, or heavy fouling of the pads. Nozzle bores and nozzle

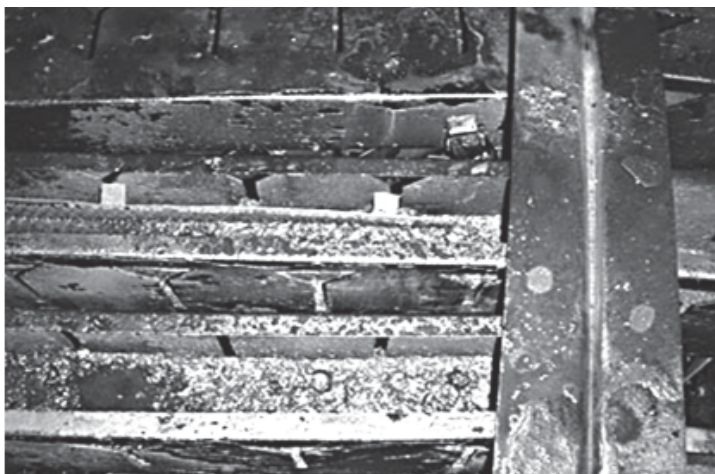
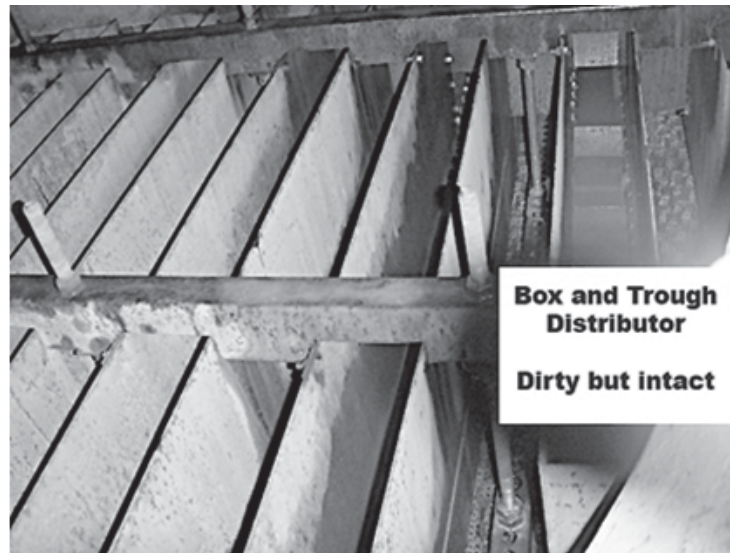
Box and trough distributors, where installed, should be checked for internal debris, obstruction of any perforations and for any distortion or damage to drip point enhancement devices (where installed), see Figure B.38 through Figure B.40. Troughs that are holding liquid probably have obstructed perforations.

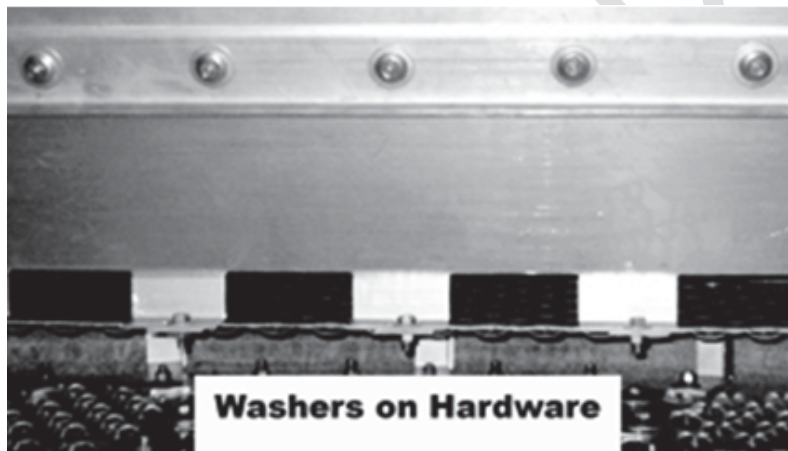
Figure B.41 - Hit the Washers, Not the Bolts

contact with the process fluids. This is fairly common on the reflux distribution system of amine towers. Striking several nuts/bolts sharply at an angle with the inspection hammer should reveal this condition (see Figure B.41). In all other cases, where hardware is actually hit with the inspection hammer, hitting the washer is best. The torque values on tower hardware are relatively low, and loosening may result from hammer blows. Tower attachments should also be sounded with an inspection hammer to check attachment welds are not cracked.

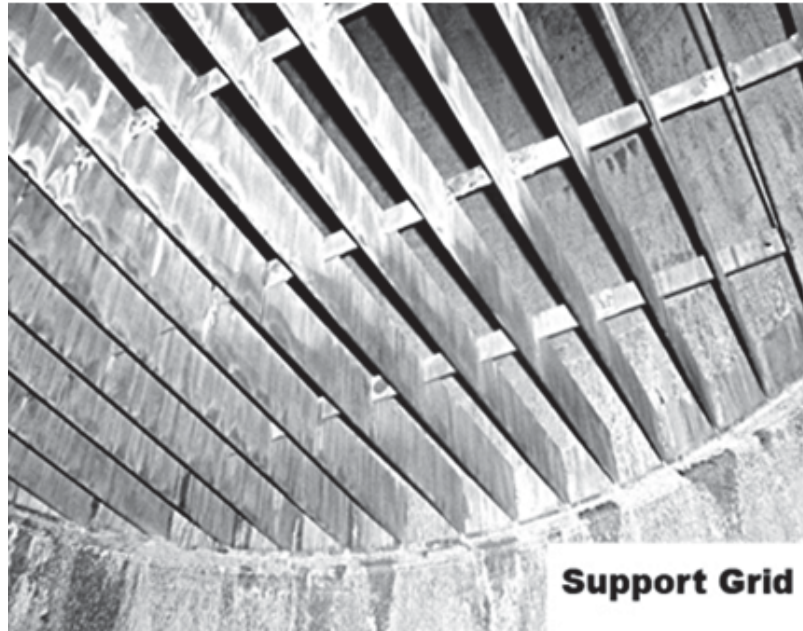
Where close visual inspection of these components is possible, particular attention should be paid to the integrity of the gas injection support plate/support grid bolting and positioning (centering), as well as the support ring attachment welds (see Figure B.45 and Figure B.46).

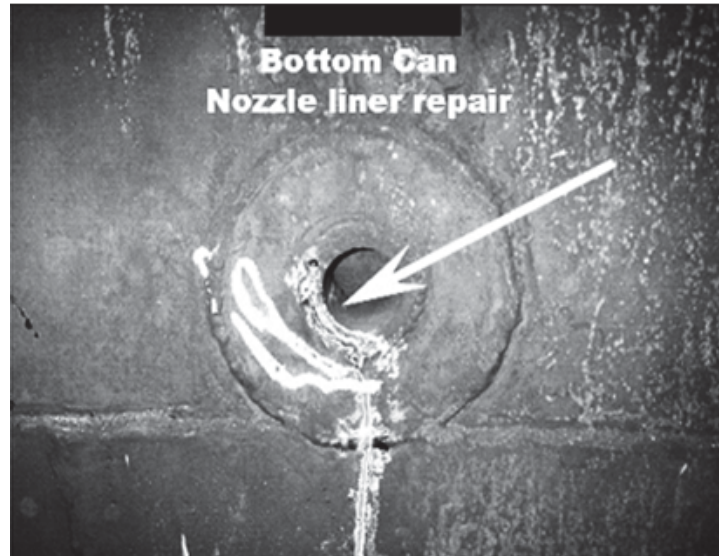
Figure B.51 - Stainless Steel Donut Cladding Breech

Clad lining usually refers to explosion bonded stainless steel cladding on carbon steel plate. This material, if properly constructed, is free of most of the cracking and bulging associated with strip lining. Some clad plate vessels utilize “donut” strip lining to cover the nozzle attachment welds (see Figure B.51).

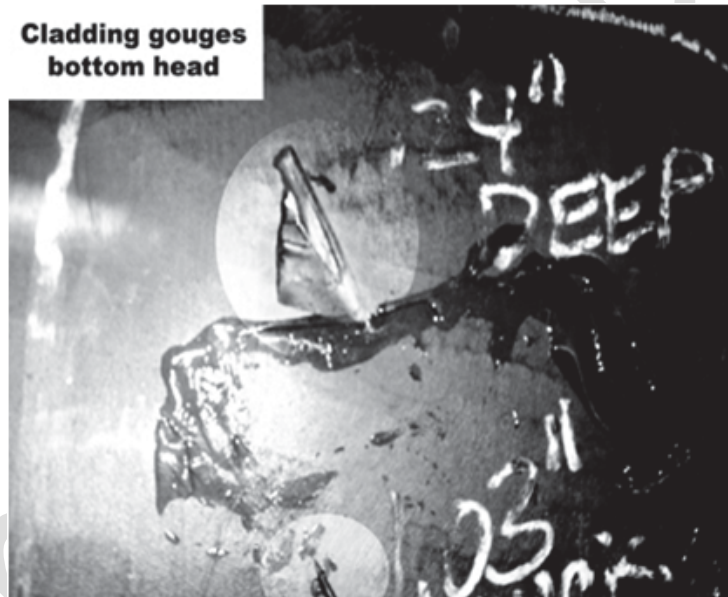
Most clad towers use weld overlay to cover the nozzle attachment weld with corrosion-resistant material and to tie the nozzle cladding into the shell/head cladding. This overlay and the “donut” liner used in place of overlay, along with gouges to the cladding and the carbon steel shell to clad shell interface weld, comprise the primary areas of cladding failure (see Figure B.52 and Figure B.53).

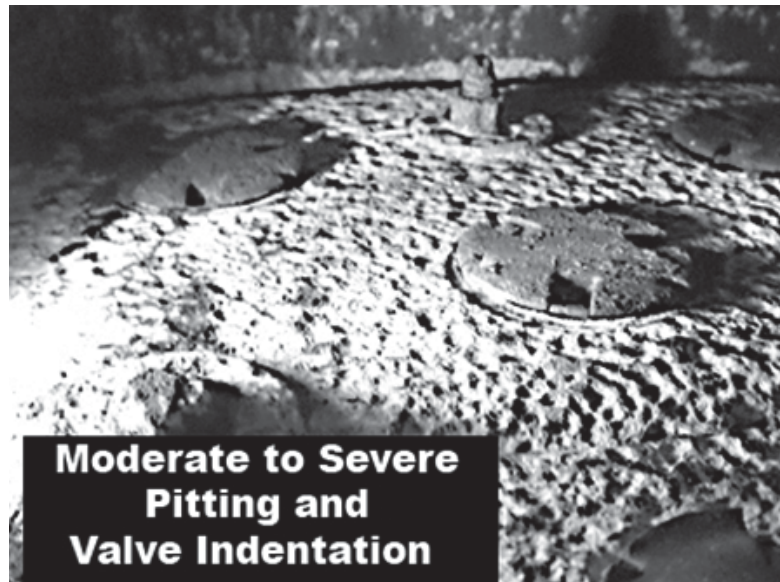
Figure B.66 - Indentation of Valves

Round valves may be checked by pushing from below and shaking to attempt to push the valve “feet” into and through the valve perforation. Valves whose feet will enter the perforation are either worn out (see Figure B.66), installed in an enlarged perforation, or have leg/feet that have not been installed correctly. Properly installed and adjusted round valves have legs that don’t touch the perforation when centered, and feet that have at least half the top length of the foot always in contact with the perforation edge when raised (see Figure B.67).

Moveable valves of all types should be manually checked for adjustment and/or thinning at each internal inspection.

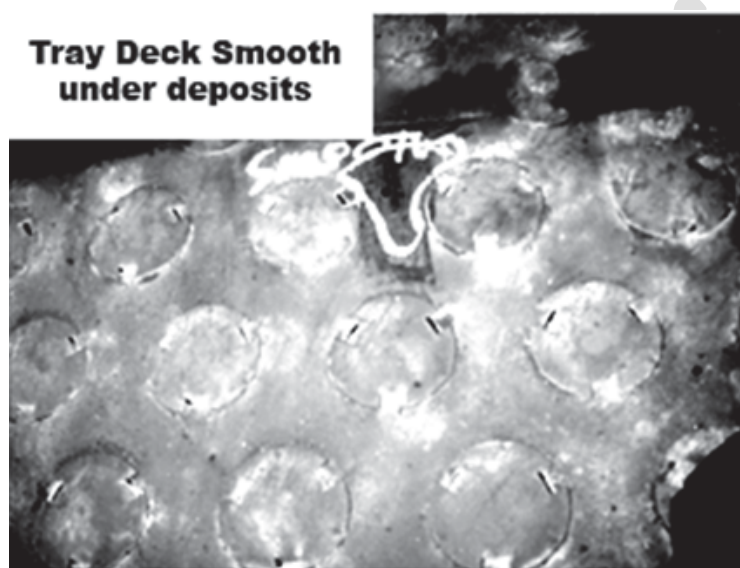
Figure B.75 - Tray Deck Should Be Scraped Clean

Corrosion of the tray panels may be generalized throughout the active and inactive panels if the tray is level. Random areas of the active and inactive tray panels should be scraped free of process residue and any process or corrosion scale (see Figure B.75). Note the presence of pitting or roughening of the tray panels. Bulging, sagging, and distortion of the tray panels may allow pooling or puddling of liquid corrosives that have precipitated from solution. Corrosive process deposits may collect in these areas as well. If present, these areas of corrosion are highly visible. Any disruption of the even plain of the tray deck should be scraped clear of process residue and any process or metallic scale for close visual examination for accelerated corrosion.

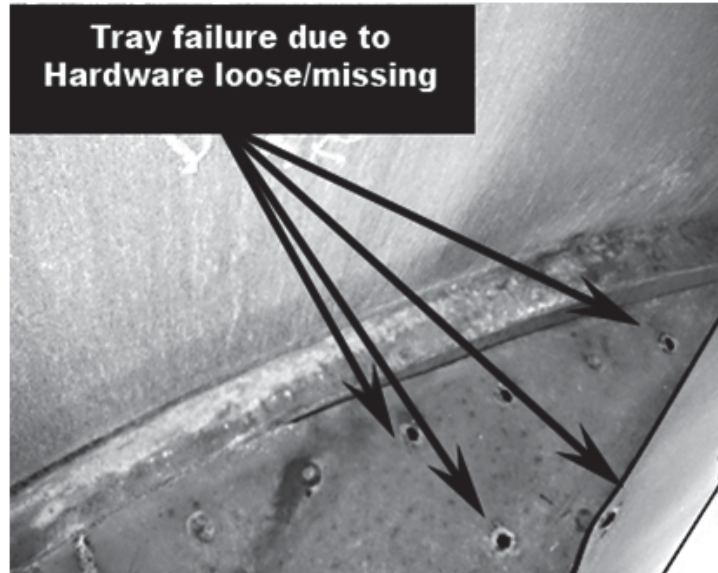
Figure B.78 - Loose and Missing Hardware Failure

Most hardware issues on trays result from mismatched hardware, i.e., carbon steel hardware installed instead of corrosion-resistant alloy hardware, hardware that is loosened due to tray vibration (see Figure B.79), galled stainless steel hardware, and improper installation. Inspection for loose hardware and hardware adrift on the tray decks is done by sounding of the tray and downcomer panels with a 4 oz to 6 oz ball peen hammer. When striking individual hardware, efforts should be made to strike the edges of washers as the washers will not gall (this also avoids damaging hardware).

Typical torque values for 0.375 in. (9.5 mm) tray hardware range from 10 ft-lb to 14 ft-lb (13.6 Nm to 19 Nm) and 0.5 in. (13mm) tray hardware torque values range from 18 ft-lb to 22 ft-lb (24.4 Nm to 29.8 Nm). Figure B.79 and Figure B.80 indicate areas that needed to be properly tightened. Particular attention should be paid to the intended purpose and location of hardware if direct contact with the hammer head is the preferred method of testing.

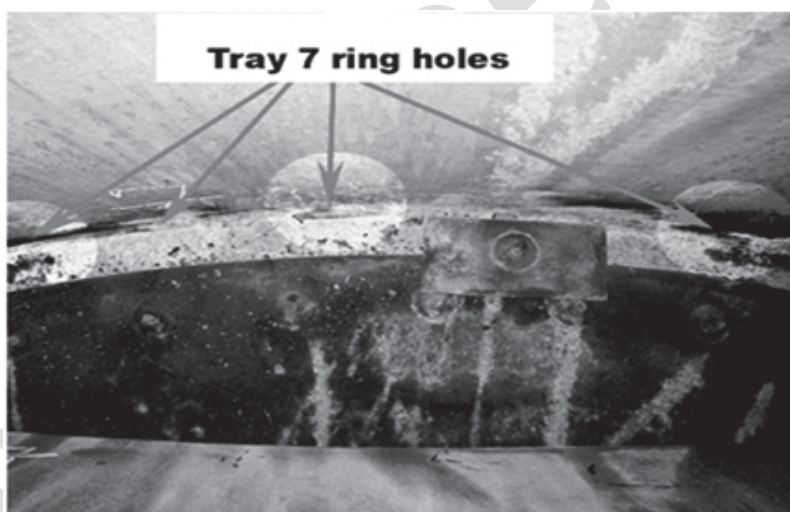
Figure B.81 - Tray Support Ring Corroded to Failure

Even with construction drawings and previous reports, direct visual confirmation of support ring attachment configuration may be the only way to ascertain how a particular ring or group of rings are attached. The tops of tray support rings (see Figure B.81), the tray support ring top side fillet welds, and the shell in this area are quite often the site of the most aggressive corrosion in a tower (see Figure B.82 and Figure B.83).

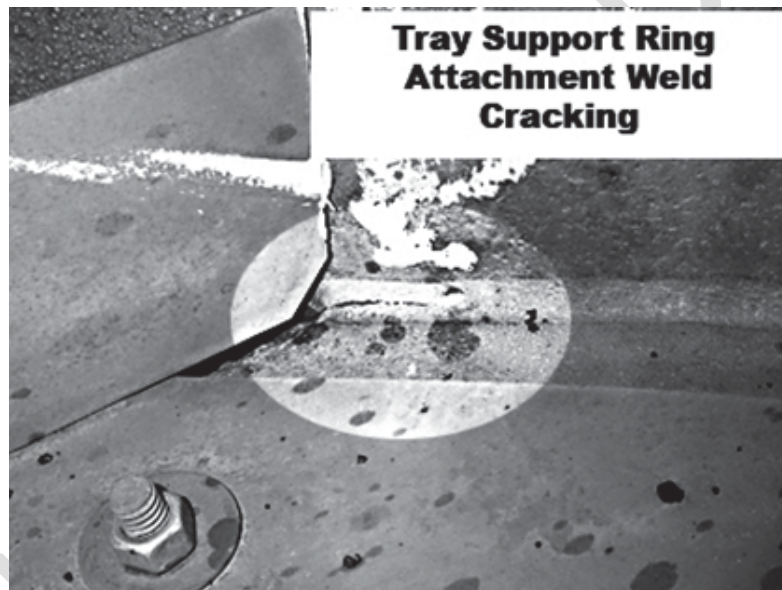
Figure B.85 - Cracking of Ring Attachment Weld

Propagation of cracking from this source into the shell is possible. When discovered, crack tip drilling may need to be performed if weld repair is not performed. If indications of corrosion between the shell and ring are present, such as corrosion residue leaking from between the stitch welds, additional NDE such as external UT should be considered. Tray support ring upper attachment welds are prone to cracking, particularly at the ends adjacent to downcomers. Careful examination of the welds should be undertaken to check no crack propagation into the shell has taken place.
